Access Compliance Report

Public Rights-of-Way

(Curb Ramps)

Intersection ID: 10889	Main Street: BRIARGROVE_DR	Cross Street: COLBY_PL	Location: SW
ADA ID: 1BA260ACDAD3	Ramp Type: Para	Initial Pass/Fail: Fail	Overall Compliance: No
Severity Score: 13.75			
Codes/Mitigation Info/Possible Solution		Field Measurements/Component Compliance

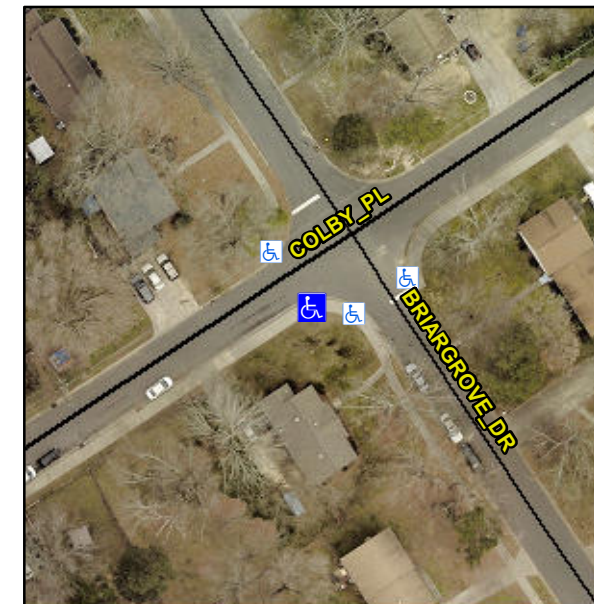
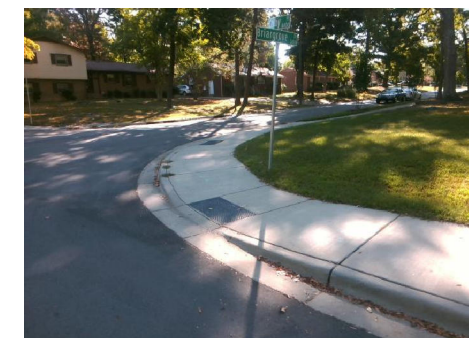
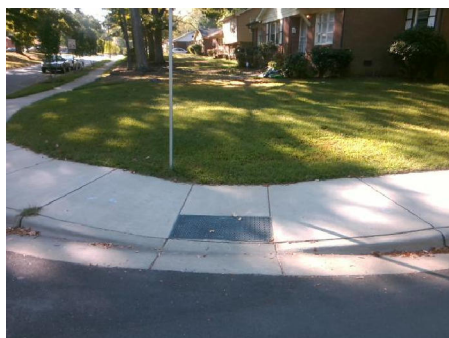
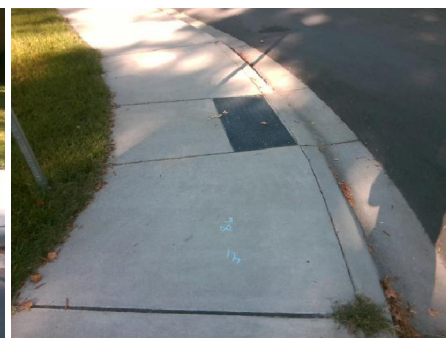
R304.3.2, R304.5.3

Compliance	Description	Data	Compliance	Description	Data
N/A	Ramp Length LT (in)	55.0	N/A	Ramp Length RT (in)	57.0
Yes	Ramp Width LT (in)	72.0	Yes	Ramp Width RT (in)	72.0
No	Ramp Slope LT (%)	8.6	Yes	Ramp Slope RT (%)	6.5
No	Ramp XSlope LT (%)	4.1	No	Ramp XSlope RT (%)	3.1
N/A	Landing Length (in)	N/A	N/A	DWS Provided?	N/A
N/A	Landing Width (in)	N/A	N/A	DWS Contrast?	N/A
N/A	Landing Slope (%)	N/A	N/A	DWS Length (in)	N/A
N/A	Landing X Slope (%)	N/A	N/A	DWS Full Width?	N/A
N/A	Landing Curb? (Y/N)	N/A	N/A	DWS Offset (in)	N/A
N/A	Shared Landing?	N/A			
N/A	Gutter Ponding?	N/A	N/A	Gutter Slope (%)	N/A
N/A	Gutter Lip Ht (in)	N/A	N/A	Gutter X Slope (%)	N/A
N/A	Painted X Walk1?	No	N/A	Painted X Walk2?	N/A
	X Walk 1 Direction	To NW		X Walk 2 Direction	N/A
N/A	X Walk 1 Width (in)	N/A	N/A	X Walk 2 Width (in)	N/A
	X Walk 1 Slope (%)	1.9		X Walk 2 Slope (%)	N/A
	X Walk 1 X Slope (%)	2.1		X Walk 2 X Slope (%)	N/A
N/A	Ramp inside XWalk1?	N/A	N/A	Ramp inside XWalk2?	N/A

Road Slope (%)	N/A	N/A	Clear Space?	N/A
	Road X Slope (%)	N/A	N/A	Clear Space to XWalk (in)	N/A
N/A	Any Obstructions?	N/A	N/A	Storm Grate/Utility Hazard?	N/A
	Obstruction Type			Storm Grate/Utility Type	
		N/A			N/A
			Yes	Surface Condition? (G/P)	Good
			N/A	Curb Slope (%)	16.0

Remove & Replace Entire Ramp.
