Access Compliance Report

Public Rights-of-Way

(Curb Ramps)

Intersection ID: 50611	Main Street: COTTON_GUM_RD	Cross Street: DOWNY_BIRCH_RD	Location: NE
ADA ID: 1C17661602DB	Ramp Type: Perp	Initial Pass/Fail: Fail	Overall Compliance: No
Severity Score: 12.5			
Codes/Mitigation Info/Possible Solution		Field Measurements/Component Compliance

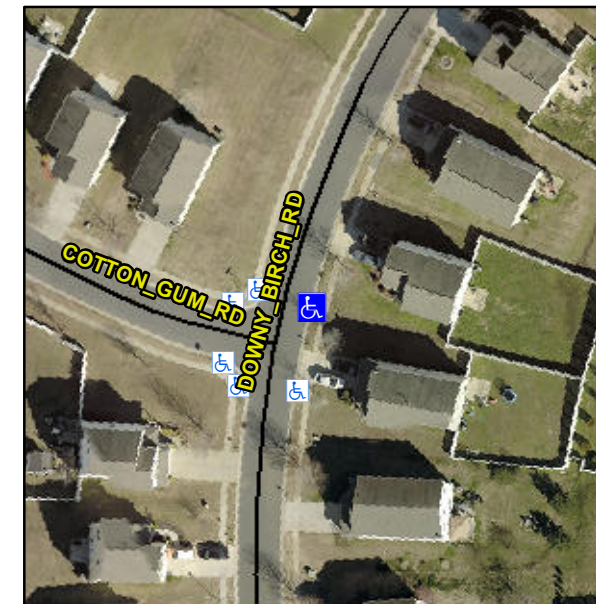
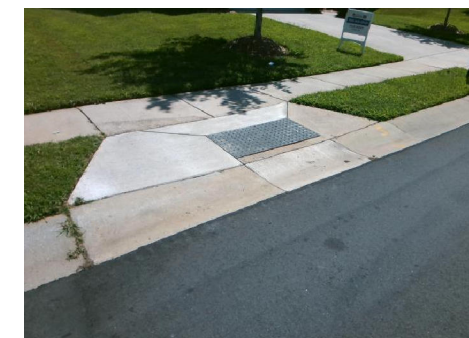
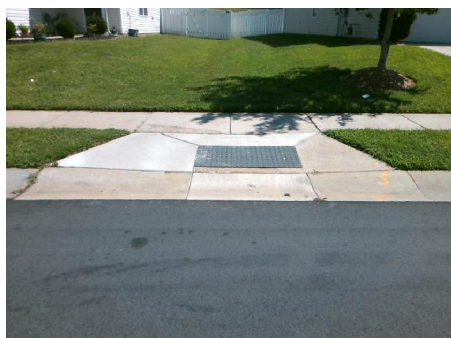
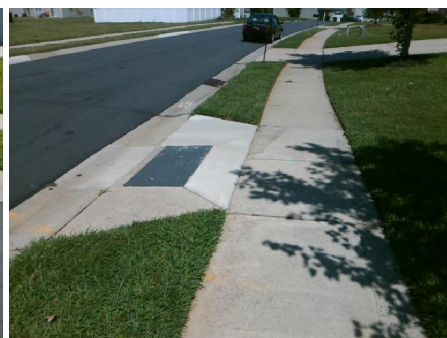
Not Found, R304.2.2

Compliance	Description	Data	Compliance	Description	Data
N/A	Ramp Length (in)	47.0	No	Ramp Slope (%)	8.8
Yes	Ramp Width (in)	48.0	Yes	Ramp XSlope (%)	1.4
N/A	Flare Type LT	N/A	N/A	Flare Type RT	N/A
N/A	Flare Slope LT (%)	N/A	N/A	Flare Slope RT (%)	N/A
N/A	Flare Traversable LT?	N/A	N/A	Flare Traversable RT?	N/A
N/A	Landing Length (in)	N/A	N/A	DWS Provided?	N/A
N/A	Landing Width (in)	N/A	N/A	DWS Contrast?	N/A
N/A	Landing Slope (%)	N/A	N/A	DWS Length (in)	N/A
N/A	Landing X Slope (%)	N/A	N/A	DWS Full Width?	N/A
N/A	Landing Curb? (Y/N)	N/A	N/A	DWS Offset (in)	N/A
N/A	Shared Landing?	N/A			
N/A	Gutter Ponding?	N/A	N/A	Gutter Slope (%)	N/A
N/A	Gutter Lip Ht (in)	N/A	N/A	Gutter X Slope (%)	N/A
N/A	Painted X Walk1?	No	N/A	Painted X Walk2?	N/A
	X Walk 1 Direction	To NW		X Walk 2 Direction	N/A
N/A	X Walk 1 Width (in)	N/A	N/A	X Walk 2 Width (in)	N/A
	X Walk 1 Slope (%)	0.3		X Walk 2 Slope (%)	N/A
	X Walk 1 X Slope (%)	1.2		X Walk 2 X Slope (%)	N/A

Remove & Replace Entire Ramp.
