Access Compliance Report Public Rights-of-Way (Curb Ramps)

Intersection ID: 17276 Main Street: PINEWOOD_CR Cross Street: PROVIDENCE_RD Location: NW

ADA ID: 1C53D1B8C19C Ramp Type: BlendTrans1 Initial Pass/Fail: Fail Overall Compliance: No Severity Score: 8.75

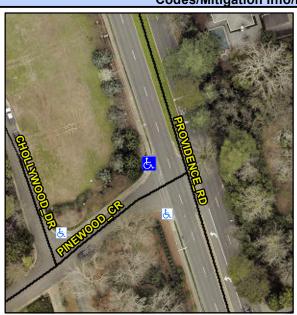
Fleid Measurements/Component Compilance						
	Compliance Description		Data	Compliance Description		Data
	N/A	Ramp Length (in)	24.5	Yes	BlendTrans Slope (%)	3.2
	No	Ramp Width (in)	47.0	Yes	BlendTrans XSlope (%)	1.3
	N/A	Flare Type LT	N/A	N/A	Flare Type RT	N/A
	N/A	Flare Slope LT (%)	N/A	N/A	Flare Slope RT (%)	N/A
	N/A	Flare Traversable LT?	N/A	N/A	Flare Traversable RT?	N/A
	N/A	Landing Length (in)	N/A	N/A	DWS Provided?	N/A
	N/A	Landing Width (in)	N/A	N/A	DWS Contrast?	N/A
	N/A	Landing Slope (%)	N/A	N/A	DWS Length (in)	N/A
	N/A	Landing X Slope (%)	N/A	N/A	DWS Full Width?	N/A
	N/A	Landing Curb? (Y/N)	N/A	N/A	DWS Offset (in)	N/A
	N/A	Shared Landing?	N/A			
	N/A	Gutter Ponding?	N/A	N/A	Gutter Slope (%)	N/A
	N/A	Gutter Lip Ht (in)	N/A	N/A	Gutter X Slope (%)	N/A
	N/A	Painted X Walk1?	No	N/A	Painted X Walk2?	No
		X Walk 1 Direction	To SE		X Walk 2 Direction	To NE
		X Walk 1 Width (in)	N/A		X Walk 2 Width (in)	N/A

X Walk 1 Slope (%)	4.2		X Walk 2 Slope (%)	5.8
		X Walk 1 X Slope (%)	7.1		X Walk 2 X Slope (%)	4.1
	N/A	Ramp inside XWalk1?	N/A	N/A	Ramp inside XWalk2?	N/A
		Road Slope (%)	0.8		Clear Space?	N/A
		Road X Slope (%)	7.2	N/A	Clear Space to XWalk (in)	N/A
	N/A	Any Obstructions?	N/A	N/A	Storm Grate/Utility Hazard?	N/A
		Obstruction Type			Storm Grate/Utility Type	
			N/A			N/A
				Yes	Surface Condition? (G/P)	Good
				N/A	Curb Slope (%)	1.3

Remove & Replace Curb Ramp With
Two New Directional Ramps or
Equivalent.
