## Access Compliance Report Public Rights-of-Way (Curb Ramps)

Intersection ID: 19296 Main Street: MEADOWOOD\_LN Cross Street: PROVIDENCE\_RD Location: SE

ADA ID: 1C95635EF3BD Ramp Type: PerpDiag Initial Pass/Fail: Fail Overall Compliance: No Severity Score: 17.5

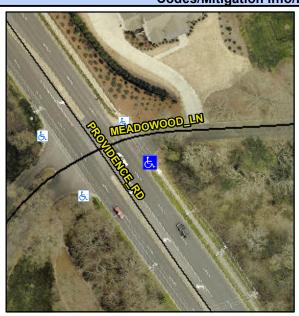
Not Found, R304.5.1

riola modela omento, compenent compilario						
	Compliance Description		Data	Compliance Description		Data
	N/A	Ramp Length (in)	60.0	Yes	Ramp Slope (%)	6.3
	No	Ramp Width (in)	35.0	Yes	Ramp XSlope (%)	0.6
	N/A	Flare Type LT	N/A	N/A	Flare Type RT	N/A
	N/A	Flare Slope LT (%)	N/A	N/A	Flare Slope RT (%)	N/A
	N/A	Flare Traversable LT?	N/A	N/A	Flare Traversable RT?	N/A
	N/A	Landing Length (in)	N/A	N/A	DWS Provided?	N/A
	N/A	Landing Width (in)	N/A	N/A	DWS Contrast?	N/A
	N/A	Landing Slope (%)	N/A	N/A	DWS Length (in)	N/A
	N/A	Landing X Slope (%)	N/A	N/A	DWS Full Width?	N/A
	N/A	Landing Curb? (Y/N)	N/A	N/A	DWS Offset (in)	N/A
	N/A	Shared Landing?	N/A			
	N/A	Gutter Ponding?	N/A	N/A	Gutter Slope (%)	N/A
	N/A	Gutter Lip Ht (in)	N/A	N/A	Gutter X Slope (%)	N/A
	N/A	Painted X Walk1?	No	N/A	Painted X Walk2?	No
		X Walk 1 Direction	To N		X Walk 2 Direction	To W
	N/A	X Walk 1 Width (in)	N/A	N/A	X Walk 2 Width (in)	N/A
		X Walk 1 Slope (%)	6.0		X Walk 2 Slope (%)	2.2

Remove & Replace Curb Ramp With
Two New Directional Ramps or
Equivalent.
