Access Compliance Report

Public Rights-of-Way

| Intersection ID: 10038861 | Main Street: STERLING_RD | Cross Street: N/A | Location: NW |
| ADA ID: 1C9E2CFC7933 | Ramp Type: BlendTrans1 | Initial Pass/Fail: Fail | Overall Compliance: No |

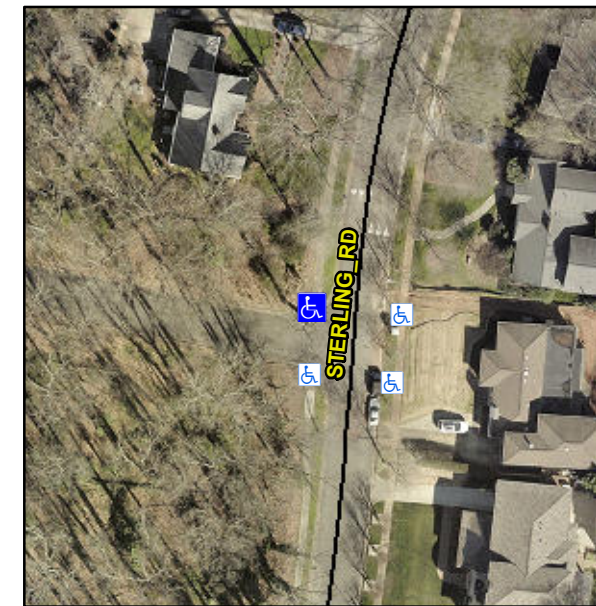
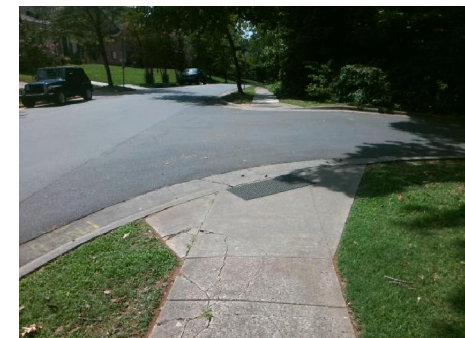
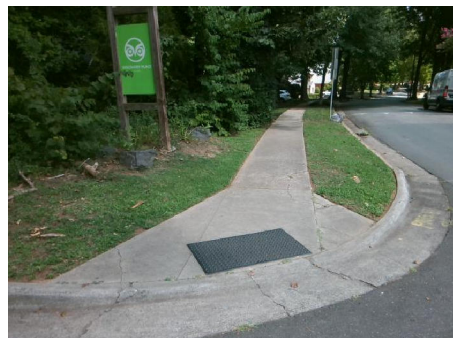
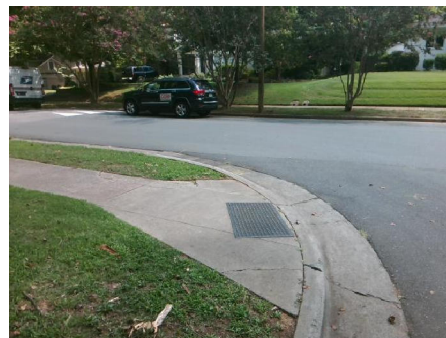
| | | Severity Score: 12.5 | |

Not Found, R304.5.3

| Compliance | Description | Data | Compliance | Description | Data |
|---|---|---|---|---|---|
| Yes | Ramp Width (in) | 48.0 | No | BlendTrans XSlope (%) | 5.5 |
| | | | No | Curb Slope (%) | 5.6 |

Remove & Replace Curb Ramp With Two New Directional Ramps or Equivalent.

Total Cost: \$ 3200.00
