## Access Compliance Report Public Rights-of-Way (Curb Ramps)

Intersection ID: N/A	Main Street: MULLAN_LN			Cross Street: REALTA_DR					NW
ADA ID: 1CA941E9E450	Ramp Type: Perp			Initial Pass/Fail: Fail Overall Compliance: No					10
Codes/Mitigation Info/Possible Solution			Field Measurements/Component Compliance						
atter the state of the	A set and a set of	Possible Solutions:	Compliance Description			Data	Data Compliance Description		
The state of the	1 mall	Remove & Replace Entire Ramp	N/A	Ramp Le	ngth (in)	96.0	Yes	Ramp Slope (%)	7.9
and the second second	in the		No	Ramp Wi		46.0	No	Ramp XSlope (%)	4.2
the same			N/A	Flare Typ	e LT	N/A	N/A	Flare Type RT	N/A
1 - I - I - IS			N/A	Flare Slo	pe LT (%)	N/A	N/A	Flare Slope RT (%)	N/A

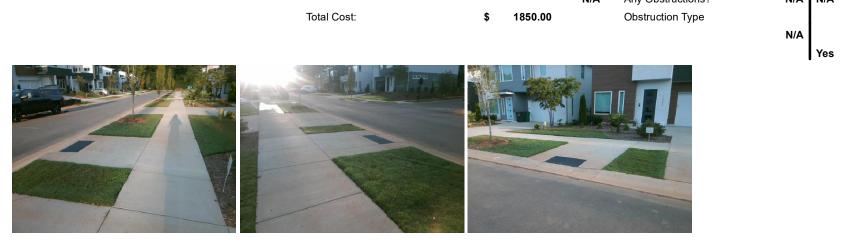
P. Ca		N/A	Flare Tra	versable LT?	N/A	N/A	Flare Traversable RT?	N/A
			N/A	Landing L	₋ength (in)	N/A	N/A	DWS Provided?	N/A
		Surveyor Notes:	N/A	Landing \	Vidth (in)	N/A	N/A	DWS Contrast?	N/A
REALTA DR	5.1	N/A	N/A	Landing S	Slope (%)	N/A	N/A	DWS Length (in)	N/A
REALERS	(F)		N/A	Landing >	K Slope (%)	N/A	N/A	DWS Full Width?	N/A
	6		N/A	Landing (	Curb? (Y/N)	N/A	N/A	DWS Offset (in)	N/A
			N/A	Shared L	anding?	N/A			
		PROW/ADA:	N/A	Gutter Po	onding?	N/A	N/A	Gutter Slope (%)	N/A
		Not Found, R304.5.1, R304.5.3	N/A	Gutter Lip	o Ht (in)	N/A	N/A	Gutter X Slope (%)	N/A
	E	,	N/A	Painted X	Walk1?	No	N/A	Painted X Walk2?	N/A
In the second		X Walk 1	Direction	To S		X Walk 2 Direction	N/A		
			N/A	X Walk 1	Width (in)	N/A	N/A	X Walk 2 Width (in)	N/A
Street 1 Name	REALTA DR			X Walk 1	Slope (%)	3.7		X Walk 2 Slope (%)	N/A
Stop Condition-Street 2	None			X Walk 1	X Slope (%)	3.7		X Walk 2 X Slope (%)	N/A
Street 2 Name	N/A		N/A	Ramp ins	ide XWalk1?	N/A	N/A	Ramp inside XWalk2?	N/A

Stop Condition-Street 1	N/A			Road Slo	pe (%)	N/A	N/A	Clear Space?	N/A
				Road X S	lope (%)	N/A	N/A	Clear Space to XWalk (in)	N/A
			N/4			N/A	N/A	Storm Grate/Utility Hazard?	N/A
		Total Cost: \$ 1	850.00	Obstructi	on Type			Storm Grate/Utility Type	
						N/A			N/A

s Surface Condition? (G/P)

Good
