Access Compliance Report

Public Rights-of-Way

Intersection ID: 18557	Main Street: MILFORD_RD	Cross Street: SENECA_PL	Location: SE
ADA ID: 1CAB68C7880E	Ramp Type: PerpDiag	Initial Pass/Fail: Fail	Overall Compliance: No
Severity Score: 33.75			
Codes/Mitigation Info/Possible Solution		Field Measurements/Component Compliance

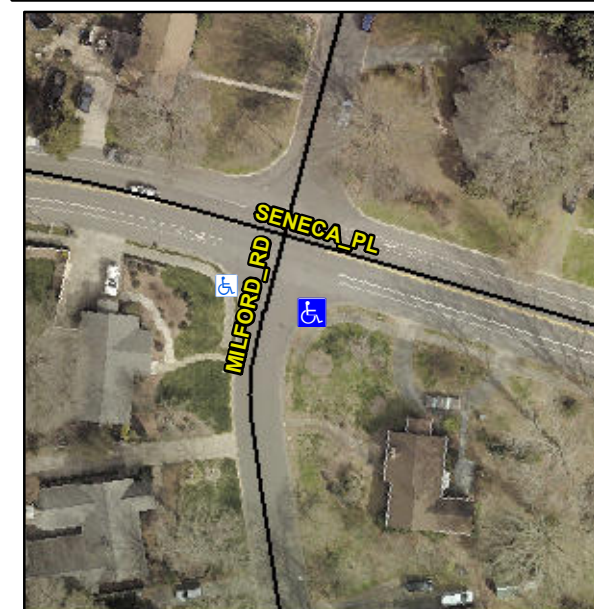
Not Found, R304.5.1, R304.5.3

Compliance	Description	Data	Compliance	Description	Data
N/A	Ramp Length (in)	108.0	Yes	Ramp Slope (%)	5.5
No	Ramp Width (in)	44.0	No	Ramp XSlope (%)	7.2
N/A	Flare Type LT	N/A	N/A	Flare Type RT	N/A
N/A	Flare Slope LT (%)	N/A	N/A	Flare Slope RT (%)	N/A
N/A	Flare Traversable LT?	N/A	N/A	Flare Traversable RT?	N/A
N/A	Landing Length (in)	N/A	N/A	DWS Provided?	N/A
N/A	Landing Width (in)	N/A	N/A	DWS Contrast?	N/A
N/A	Landing Slope (%)	N/A	N/A	DWS Length (in)	N/A
N/A	Landing X Slope (%)	N/A	N/A	DWS Full Width?	N/A
N/A	Landing Curb? (Y/N)	N/A	N/A	DWS Offset (in)	N/A
N/A	Shared Landing?	N/A			
N/A	Gutter Ponding?	N/A	N/A	Gutter Slope (%)	N/A
N/A	Gutter Lip Ht (in)	N/A	N/A	Gutter X Slope (%)	N/A
N/A	Painted X Walk1?	No	N/A	Painted X Walk2?	No
	X Walk 1 Direction	To NE		X Walk 2 Direction	To NW
N/A	X Walk 1 Width (in)	N/A	N/A	X Walk 2 Width (in)	N/A
	X Walk 1 Slope (%)	1.1		X Walk 2 Slope (%)	3.9
	X Walk 1 X Slope (%)	4.5		X Walk 2 X Slope (%)	0.5

N/A	Ramp inside XWalk1?	N/A	N/A	Ramp inside XWalk2?	N/A
	Road Slope (%)	0.6	N/A	Clear Space?	N/A
	Road X Slope (%)	3.6	N/A	Clear Space to XWalk (in)	N/A
N/A	Any Obstructions?	N/A	N/A	Storm Grate/Utility Hazard?	N/A
	Obstruction Type			Storm Grate/Utility Type	
		N/A			N/A
		Yes		Surface Condition? (G/P)	Good

Remove & Replace Curb Ramp With Two New Directional Ramps or Equivalent.
