Access Compliance Report Public Rights-of-Way (Curb Ramps)

Main Street: W_TYVOLA_RD Intersection ID: N/A Cross Street: N/A Location: ADA ID: 1CE5776F09C6 **Overall Compliance: No** Ramp Type: Perp Initial Pass/Fail: Fail Severity Score: 13.75

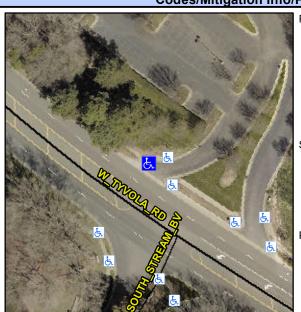
| Field Measurements/Component Compliance | | | | | |
|---|--|---|---|---|---|
| N/A | Ramp Length (in) | 41.0 | No | Ramp Slope (%) | 11.1 |
| Yes | Ramp Width (in) | 48.0 | No | Ramp XSlope (%) | 2.6 |

Possible Solutions: Remove & Replace Entire Ramp. Surveyor Notes: N/A PROW/ADA: Not Found, R304.2.2, R304.5.3
