# Access Compliance Report Public Rights-of-Way (Curb Ramps)

Intersection ID: 7563      Main Street: WALDON\_RD      Cross Street: SHARPES\_CR      Location: NW

ADA ID: 1D204E091D5B      Ramp Type: BlendTrans1      Initial Pass/Fail: Fail      Overall Compliance: No      Severity Score: 33.75

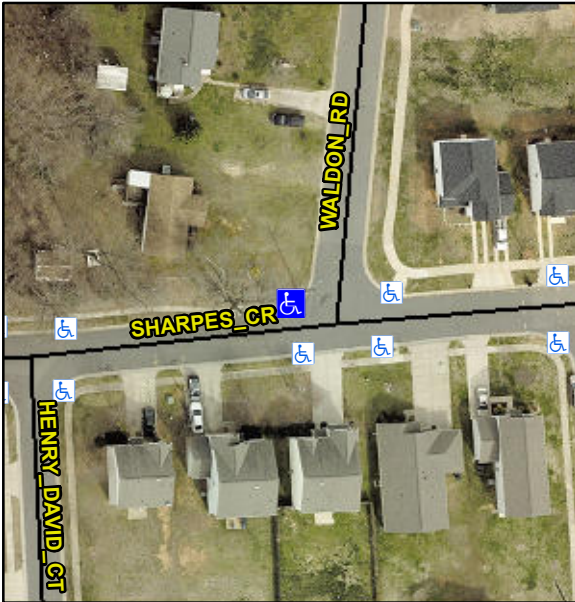
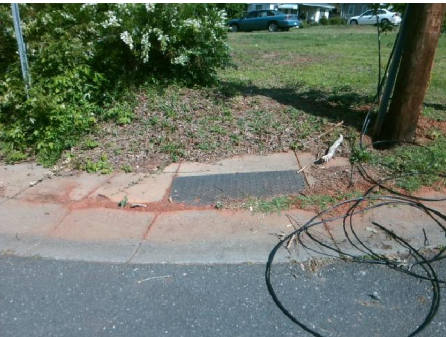
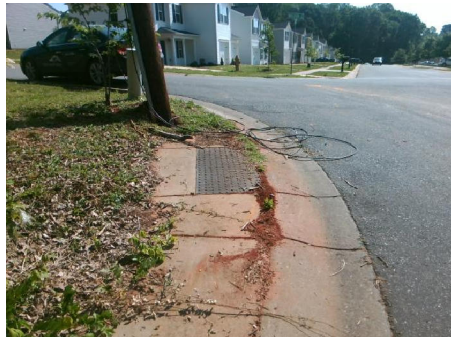
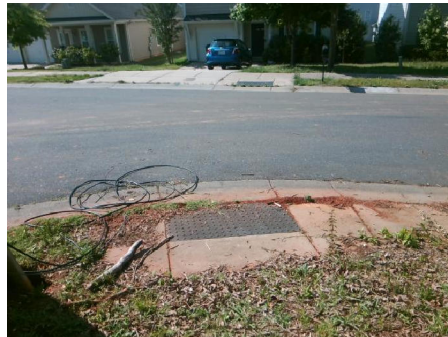
**NO RT SW**

**Not Found, R304.5.1, R304.5.3**

Compliance	Description	Data	Compliance	Description	Data
N/A	Ramp Length (in)	48.0	Yes	BlendTrans Slope (%)	1.9
No	Ramp Width (in)	47.5	No	BlendTrans XSlope (%)	9.6
N/A	Flare Type LT	N/A	N/A	Flare Type RT	N/A
N/A	Flare Slope LT (%)	N/A	N/A	Flare Slope RT (%)	N/A
N/A	Flare Traversable LT?	N/A	N/A	Flare Traversable RT?	N/A
N/A	Landing Length (in)	N/A	N/A	DWS Provided?	N/A
N/A	Landing Width (in)	N/A	N/A	DWS Contrast?	N/A
N/A	Landing Slope (%)	N/A	N/A	DWS Length (in)	N/A
N/A	Landing X Slope (%)	N/A	N/A	DWS Full Width?	N/A
N/A	Landing Curb? (Y/N)	N/A	N/A	DWS Offset (in)	N/A
N/A	Shared Landing?	N/A			
N/A	Gutter Ponding?	N/A	N/A	Gutter Slope (%)	N/A
N/A	Gutter Lip Ht (in)	N/A	N/A	Gutter X Slope (%)	N/A
N/A	Painted X Walk1?	No	N/A	Painted X Walk2?	No
	X Walk 1 Direction	To S		X Walk 2 Direction	To E
	X Walk 1 Width (in)	N/A		X Walk 2 Width (in)	N/A
	X Walk 1 Slope (%)	2.8		X Walk 2 Slope (%)	5.8
	X Walk 1 X Slope (%)	5.5		X Walk 2 X Slope (%)	4.5

N/A	Ramp inside XWalk1?	N/A	N/A	Ramp inside XWalk2?	N/A
	Road Slope (%)	6.6		Clear Space?	N/A
	Road X Slope (%)	0.4	N/A	Clear Space to XWalk (in)	N/A
N/A	Any Obstructions?	N/A	N/A	Storm Grate/Utility Hazard?	N/A
	Obstruction Type			Storm Grate/Utility Type	
		N/A			N/A
Yes	Surface Condition? (G/P)		Yes		Good
No	Curb Slope (%)		No		11.8

**Remove & Replace Curb Ramp With Two New Directional Ramps or Equivalent.**
