Access Compliance Report

Public Rights-of-Way

(Curb Ramps)

Intersection ID: 10427	Main Street: CALLAHAN_ST	Cross Street: POLK_ST	Location: E
ADA ID: 1D424B36FF8A	Ramp Type: Perp	Initial Pass/Fail: Fail	Overall Compliance: No
			Severity Score: 48.75

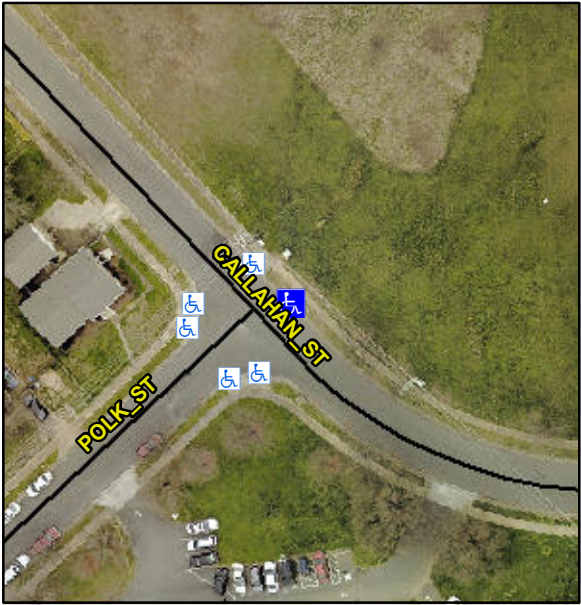
Possible Solutions:		Compliance	Description	Data
	Remove & Replace Entire Ramp.		No	Ramp Length (in)	59.0
			No	Ramp Width (in)	41.0
			N/A	Flare Type LT	N/A
			N/A	Flare Slope LT (%)	N/A
			N/A	Flare Traversable LT?	N/A
			N/A	Landing Length (in)	N/A
			N/A	Landing Width (in)	N/A
			N/A	Landing Slope (%)	N/A
			N/A	Landing X Slope (%)	N/A
<p>Surveyor Notes:</p> <p>N/A</p> <p>PROW/ADA:</p> <p>Not Found, R304.5.1, R304.2.2, R302.7</p>			N/A	Flare Type RT	N/A
			N/A	Flare Slope RT (%)	N/A
			N/A	Flare Traversable RT?	N/A
			N/A	DWS Provided?	N/A
			N/A	DWS Contrast?	N/A
			N/A	DWS Length (in)	N/A
			N/A	DWS Full Width?	N/A
			N/A	DWS Offset (in)	N/A
			N/A	Gutter Ponding?	N/A
			N/A	Gutter Lip Ht (in)	3.0
<p>Total Cost:</p> <p>\$ 1850.00</p>			No	Painted X Walk1?	N/A
			N/A	X Walk 1 Direction	To SW
			N/A	X Walk 1 Width (in)	N/A

N/A	X Walk 1 Slope (%)	4.0
			N/A	X Walk 1 X Slope (%)	2.2
			N/A	Ramp inside XWalk1?	N/A
			N/A	Road Slope (%)	N/A
			N/A	Road X Slope (%)	N/A
			N/A	Any Obstructions?	N/A
			N/A	Obstruction Type	N/A
			No	Surface Condition? (G/P)	Poor
