Access Compliance Report

Public Rights-of-Way

(Curb Ramps)

Intersection ID: 47846	Main Street: ALVARADO_WY	Cross Street: STONE_PORCH_RD	Location: SE
ADA ID: 1DA374AAB299	Ramp Type: BlendTrans1	Initial Pass/Fail: Fail	Overall Compliance: No
Severity Score: 8.75			
Codes/Mitigation Info/Possible Solution		Field Measurements/Component Compliance

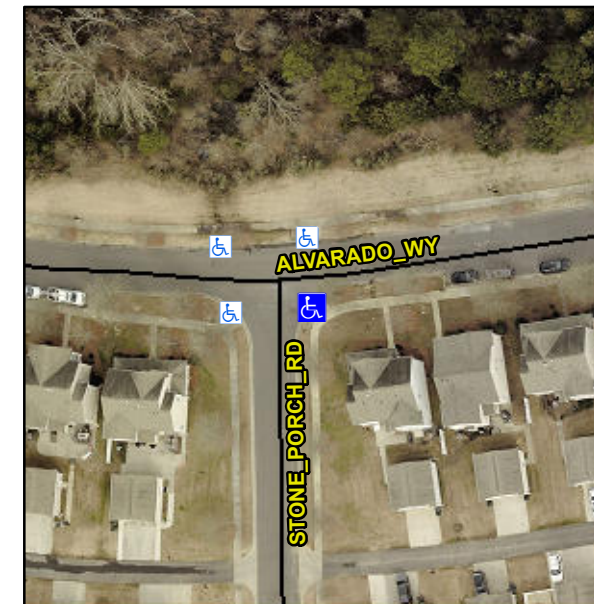
Not Found, R304.5.1

Remove & Replace Curb Ramp With Two New Directional Ramps or Equivalent.

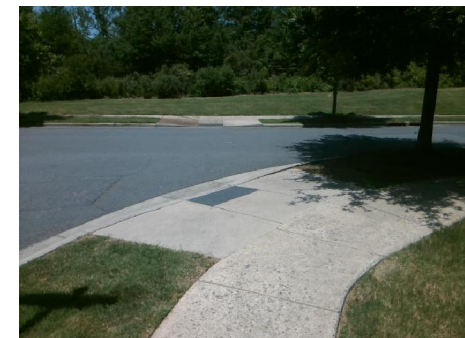
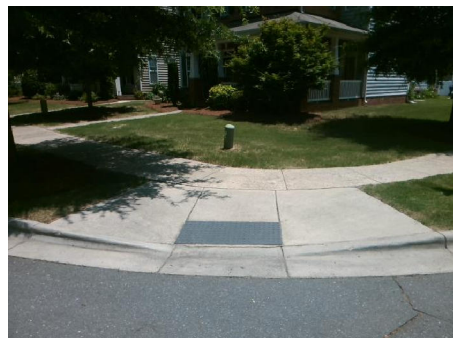
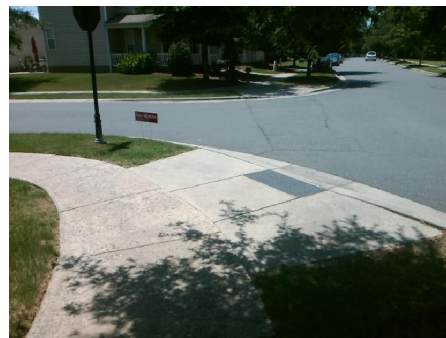
Compliance	Description	Data	Compliance	Description	Data
N/A	Ramp Length (in)	78.0	Yes	BlendTrans Slope (%)	4.4
No	Ramp Width (in)	46.0	Yes	BlendTrans XSlope (%)	0.9
N/A	Flare Type LT	N/A	N/A	Flare Type RT	N/A
N/A	Flare Slope LT (%)	N/A	N/A	Flare Slope RT (%)	N/A
N/A	Flare Traversable LT?	N/A	N/A	Flare Traversable RT?	N/A
N/A	Landing Length (in)	N/A	N/A	DWS Provided?	N/A
N/A	Landing Width (in)	N/A	N/A	DWS Contrast?	N/A
N/A	Landing Slope (%)	N/A	N/A	DWS Length (in)	N/A
N/A	Landing X Slope (%)	N/A	N/A	DWS Full Width?	N/A
N/A	Landing Curb? (Y/N)	N/A	N/A	DWS Offset (in)	N/A
N/A	Shared Landing?	N/A			
N/A	Gutter Ponding?	N/A	N/A	Gutter Slope (%)	N/A
N/A	Gutter Lip Ht (in)	N/A	N/A	Gutter X Slope (%)	N/A
N/A	Painted X Walk1?	No	N/A	Painted X Walk2?	No
	X Walk 1 Direction	To N		X Walk 2 Direction	To W
	X Walk 1 Width (in)	N/A		X Walk 2 Width (in)	N/A
	X Walk 1 Slope (%)	1.9		X Walk 2 Slope (%)	0.2
	X Walk 1 X Slope (%)	1.6		X Walk 2 X Slope (%)	1.6

N/A	Ramp inside XWalk1?	N/A	N/A	Ramp inside XWalk2?	N/A
	Road Slope (%)	1.0		Clear Space?	N/A
	Road X Slope (%)	0.9	N/A	Clear Space to XWalk (in)	N/A
N/A	Any Obstructions?	N/A	N/A	Storm Grate/Utility Hazard?	N/A
	Obstruction Type			Storm Grate/Utility Type	
		N/A			N/A
			Yes	Surface Condition? (G/P)	Good
			No	Curb Slope (%)	6.7
