Access Compliance Report Public Rights-of-Way (Curb Ramps)

Intersection ID: 10023924Main Street: CONLAN_CRCross Street: N/ALocation:NADA ID: 1DC7100BD265Ramp Type: PerpInitial Pass/Fail: FailOverall Compliance: NoSeverity Score:25

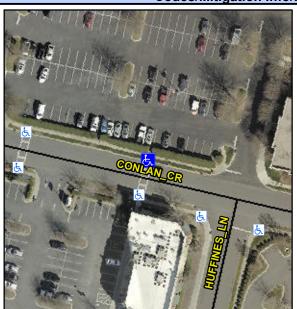
u33/1	an. ran Overan	Compilan	100. IN	o deventy ocore.					
Field Measurements/Component Compliance									
Comp	oliance Description	Data	Compliance Description		Data				
N/A	Ramp Length (in)	48.0	No	Ramp Slope (%)	13.4				
Yes	Ramp Width (in)	61.0	Yes	Ramp XSlope (%)	1.3				
N/A	Flare Type LT	N/A	N/A	Flare Type RT	N/A				
N/A	Flare Slope LT (%)	N/A	N/A	Flare Slope RT (%)	N/A				
N/A	Flare Traversable LT?	N/A	N/A	Flare Traversable RT?	N/A				
N/A	Landing Length (in)	N/A	N/A	DWS Provided?	N/A				
N/A	Landing Width (in)	N/A	N/A	DWS Contrast?	N/A				
N/A	Landing Slope (%)	N/A	N/A	DWS Length (in)	N/A				
N/A	Landing X Slope (%)	N/A	N/A	DWS Full Width?	N/A				
N/A	Landing Curb? (Y/N)	N/A	N/A	DWS Offset (in)	N/A				
N/A	Shared Landing?	N/A							
N/A	Gutter Ponding?	N/A	N/A	Gutter Slope (%)	N/A				
N/A	Gutter Lip Ht (in)	N/A	N/A	Gutter X Slope (%)	N/A				
N/A	Painted X Walk1?	Yes	N/A	Painted X Walk2?	N/A				
	X Walk 1 Direction	To SW		X Walk 2 Direction	N/A

N/A	X Walk 1 Width (in)	102.5	N/A	X Walk 2 Width (in)	N/A				
	X Walk 1 Slope (%)	3.3		X Walk 2 Slope (%)	N/A				
	X Walk 1 X Slope (%)	3.1		X Walk 2 X Slope (%)	N/A				
N/A	Ramp inside XWalk1?	Yes	N/A	Ramp inside XWalk2?	N/A				
	Road Slope (%)	N/A	N/A	Clear Space?	N/A				
	Road X Slope (%)	N/A	N/A	Clear Space to XWalk (in)	N/A				
N/A	Any Obstructions?	N/A	N/A	Storm Grate/Utility Hazard?	N/A				
	Obstruction Type		l	Storm Grate/Utility Type					
		N/A			N/A				
			Yes	Surface Condition? (G/P)	Good				
MAJA 34000

Possible Solutions:	Com
Remove & Replace Entire Ramp.	N/A
	Yes
	N/A
	N/A
	N/A
	N/A
Surveyor Notes:	N/A
N/A	N/A
	N/A
	N/A
	N/A
PROW/ADA:	N/A
Not Found, R304.2.2	N/A
,	N/A
	N/A
	N/A
