# Access Compliance Report

## Public Rights-of-Way

### (Curb Ramps)

Intersection ID: 23880	Main Street: CHINA GROVE CHURCH RD	Cross Street: STERLING LN	Location:	NW
ADA ID: 1DC77E1EC5BF	Ramp Type: PerpDiag	Initial Pass/Fail: Fail	Overall Compliance: No	Severity Score: 35
Codes/Mitigation Info/Possible Solution		Field Measurements/Component Compliance

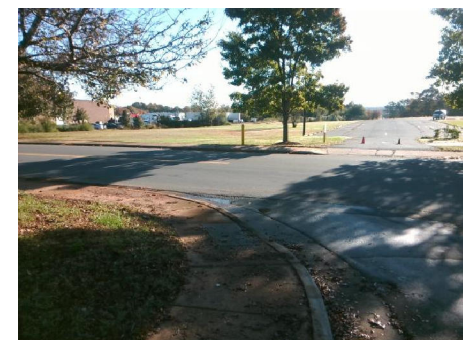
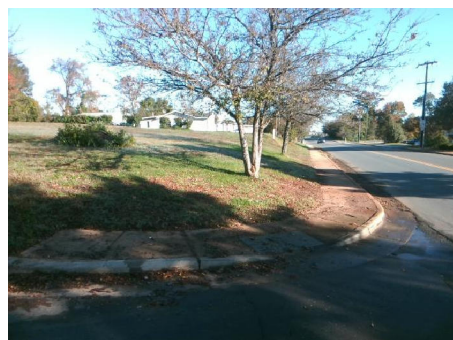
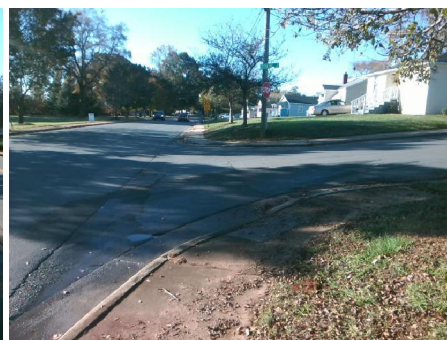
**Not Found, R304.5.1, R304.2.2, R304.5.3**

Compliance	Description	Data	Compliance	Description	Data
N/A	Ramp Length (in)	48.0	No	Ramp Slope (%)	14.4
No	Ramp Width (in)	46.0	No	Ramp XSlope (%)	4.9
N/A	Flare Type LT	N/A	N/A	Flare Type RT	N/A
N/A	Flare Slope LT (%)	N/A	N/A	Flare Slope RT (%)	N/A
N/A	Flare Traversable LT?	N/A	N/A	Flare Traversable RT?	N/A
N/A	Landing Length (in)	N/A	N/A	DWS Provided?	N/A
N/A	Landing Width (in)	N/A	N/A	DWS Contrast?	N/A
N/A	Landing Slope (%)	N/A	N/A	DWS Length (in)	N/A
N/A	Landing X Slope (%)	N/A	N/A	DWS Full Width?	N/A
N/A	Landing Curb? (Y/N)	N/A	N/A	DWS Offset (in)	N/A
N/A	Shared Landing?	N/A			
N/A	Gutter Ponding?	N/A	N/A	Gutter Slope (%)	N/A
N/A	Gutter Lip Ht (in)	N/A	N/A	Gutter X Slope (%)	N/A
N/A	Painted X Walk1?	No	N/A	Painted X Walk2?	No
	X Walk 1 Direction	To SW		X Walk 2 Direction	To SE
N/A	X Walk 1 Width (in)	N/A	N/A	X Walk 2 Width (in)	N/A
	X Walk 1 Slope (%)	0.6		X Walk 2 Slope (%)	1.0
	X Walk 1 X Slope (%)	7.0		X Walk 2 X Slope (%)	0.9

N/A	Ramp inside XWalk1?	N/A	N/A	Ramp inside XWalk2?	N/A
	Road Slope (%)	5.0	N/A	Clear Space?	N/A
	Road X Slope (%)	2.5	N/A	Clear Space to XWalk (in)	N/A
N/A	Any Obstructions?	N/A	N/A	Storm Grate/Utility Hazard?	N/A
	Obstruction Type			Storm Grate/Utility Type	
		N/A			N/A
			Yes	Surface Condition? (G/P)	Good

**Remove & Replace Curb Ramp With Two New Directional Ramps or Equivalent.**
