## Access Compliance Report Public Rights-of-Way (Curb Ramps)

Intersection ID: 13197
 Main Street: S\_MCDOWELL\_ST
 Cross Street: E\_4TH\_ST
 Location:
 S

ADA ID: 1DF33C5184F9
 Ramp Type: BlendTrans1
 Initial Pass/Fail: Fail
 Overall Compliance: No
 Severity Score: 12.5

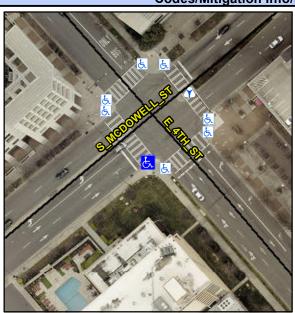
Not Found, R304.5.3

Field Measurements/Component Compliance							
Compliance Description		Description Data Compliance Description		Data			
N/A	Ramp Length (in)	59.0	Yes	BlendTrans Slope (%)	2.3		
Yes	Ramp Width (in)	48.0	No	BlendTrans XSlope (%)	6.7		
N/A	Flare Type LT	N/A	N/A	Flare Type RT	N/A		
N/A	Flare Slope LT (%)	N/A	N/A	Flare Slope RT (%)	N/A		
N/A	Flare Traversable LT?	N/A	N/A	Flare Traversable RT?	N/A		
N/A	Landing Length (in)	N/A	N/A	DWS Provided?	N/A		
N/A	Landing Width (in)	N/A	N/A	DWS Contrast?	N/A		
N/A	Landing Slope (%)	N/A	N/A	DWS Length (in)	N/A		
N/A	Landing X Slope (%)	N/A	N/A	DWS Full Width?	N/A		
N/A	Landing Curb? (Y/N)	N/A	N/A	DWS Offset (in)	N/A		
N/A	Shared Landing?	N/A					
N/A	Gutter Ponding?	N/A	N/A	Gutter Slope (%)	N/A		
N/A	Gutter Lip Ht (in)	N/A	N/A	Gutter X Slope (%)	N/A		
N/A	Painted X Walk1?	Yes	N/A	Painted X Walk2?	N/A		
	X Walk 1 Direction	To NW		X Walk 2 Direction	N/A		
	X Walk 1 Width (in)	184.0		X Walk 2 Width (in)	N/A

X Walk 1 Slope (%)	3.6		X Walk 2 Slope (%)	N/A		
	X Walk 1 X Slope (%)	2.6		X Walk 2 X Slope (%)	N/A		
N/A	Ramp inside XWalk1?	Yes	N/A	Ramp inside XWalk2?	N/A		
	Road Slope (%)	2.6		Clear Space?	N/A		
	Road X Slope (%)	3.6	N/A	Clear Space to XWalk (in)	N/A		
N/A	Any Obstructions?	N/A	N/A	Storm Grate/Utility Hazard?	N/A		
	Obstruction Type			Storm Grate/Utility Type			
		N/A			N/A		
			Yes	Surface Condition? (G/P)	Good		
			No	Curb Slope (%)	8.2		
131

Remove & Replace Curb Ramp With Two New Directional Ramps or Equivalent.
