Access Compliance Report Public Rights-of-Way (Curb Ramps)

Intersection ID: 10033070 Main Street: NORTH_COMMUNITY_HOUSE_Ross Street: N/A Location: SE

ADA ID: 1E48FE084A0B Ramp Type: Perp Initial Pass/Fail: Fail Overall Compliance: No Severity Score: 13.75

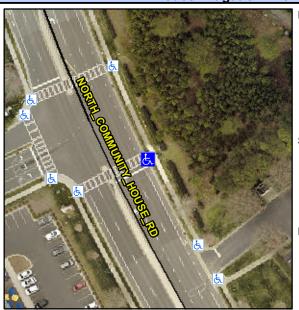
Field Measurements/Component Compliance							
Compl	liance Description	Data	Comp	liance	Description	Data	
N/A	Ramp Length (in)	49.0	No	Ramp	Slope (%)	9.8	
Yes	Ramp Width (in)	60.0	Yes	Ramp	XSlope (%)	2.9	
N/A	Flare Type LT	N/A	N/A	Flare	Type RT	N/A	
N/A	Flare Slope LT (%)	N/A	N/A	Flare	Slope RT (%)	N/A	
N/A	Flare Traversable LT?	N/A	N/A	Flare	Traversable RT?	N/A	
N/A	Landing Length (in)	N/A	N/A	DWS	Provided?	N/A	
N/A	Landing Width (in)	N/A	N/A	DWS	Contrast?	N/A	
N/A	Landing Slope (%)	N/A	N/A	DWS	Length (in)	N/A	
N/A	Landing X Slope (%)	N/A	N/A	DWS	Full Width?	N/A	
N/A	Landing Curb? (Y/N)	N/A	N/A	DWS	Offset (in)	N/A	
N/A	Shared Landing?	N/A					
N/A	Gutter Ponding?	N/A	N/A	Gutte	r Slope (%)	N/A	
N/A	Gutter Lip Ht (in)	N/A	N/A	Gutte	r X Slope (%)	N/A	
N/A	Painted X Walk1?	Yes	N/A	Paint	ed X Walk2?	N/A	
	X Walk 1 Direction	To SW		X Wa	lk 2 Direction	N/A	
N/A	X Walk 1 Width (in)	111.0	N/A	X Wa	lk 2 Width (in)	N/A

Possible Solution	
Possible Solutions:	Con
Remove & Replace Entire Ramp.	N/A
	Yes
	N/A
	N/A
	N/A
	N/A
Surveyor Notes:	N/A
N/A	N/A
	N/A
	N/A
	N/A
PROW/ADA:	N/A
Not Found, R304.2.2	N/A
	N/A
	N/A
	N/A
