Access Compliance Report

Public Rights-of-Way

(Curb Ramps)

Intersection ID: 50608	Main Street: DENBUR_DR	Cross Street: DOWNY_BIRCH_RD	Location: NW
ADA ID: 1E82EC0E0808	Ramp Type: Combination2	Initial Pass/Fail: Fail	Overall Compliance: No
		Severity Score: 22.5

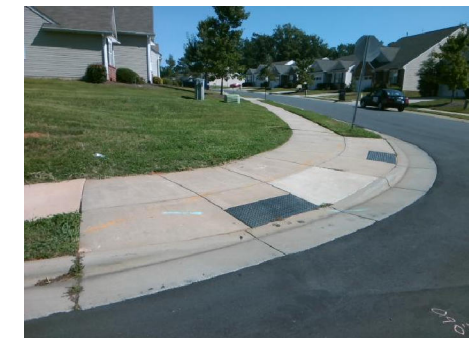
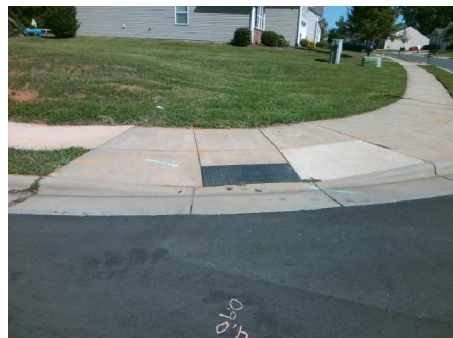
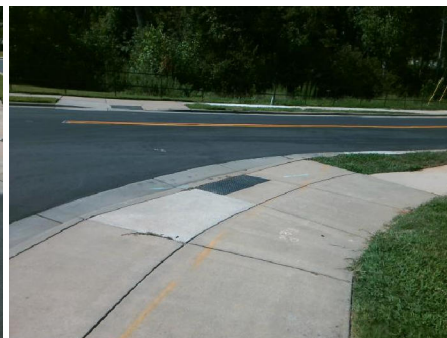
LT RP < 5%

Not Found, R304.5.1, R304.3.2

Remove & Replace Entire Ramp.
