# Access Compliance Report

## Public Rights-of-Way

### (Curb Ramps)

Intersection ID: 9061	Main Street: LUCENA_ST	Cross Street: NORRIS_AV	Location: SW
ADA ID: 1FFAFF8635E3	Ramp Type: Combination2Diag	Initial Pass/Fail: Fail	Overall Compliance: No
		Severity Score: 0

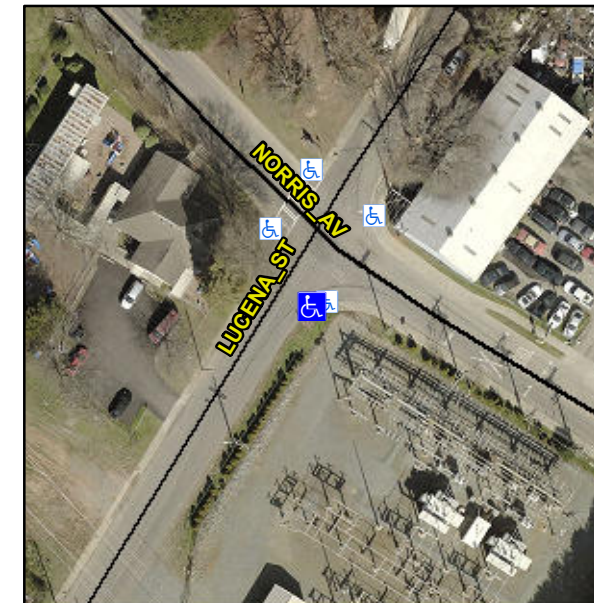
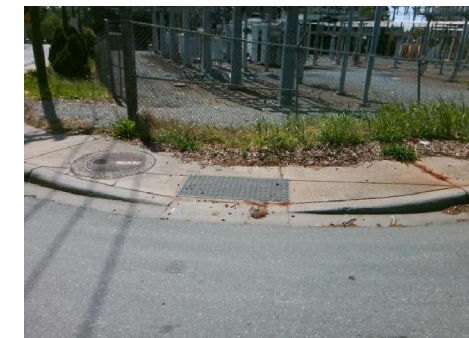
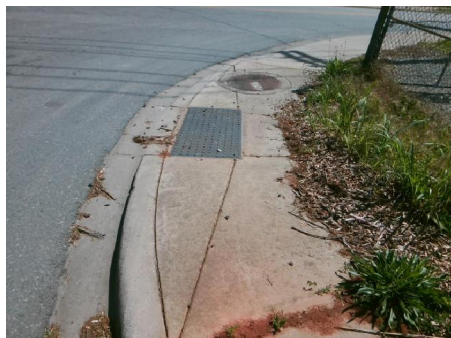
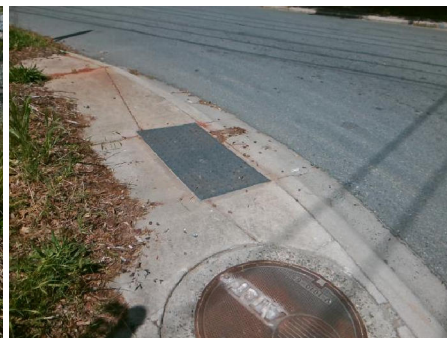
**LT RP < 5%**

**R304.5.1, R304.5.3, R304.3.2**

Compliance	Description	Data	Compliance	Description	Data
N/A	Ramp Length LT (in)	78.0	N/A	Ramp Length RT (in)	66.0
Yes	Ramp Width LT (in)	59.0	Yes	Ramp Width RT (in)	59.0
Yes	Ramp Slope LT (%)	1.8	No	Ramp Slope RT (%)	10.5
No	Ramp XSlope LT (%)	2.4	Yes	Ramp XSlope RT (%)	0.4
N/A	Ramp Length (in)	48.0	Yes	Ramp Slope (%)	1.3
No	Ramp Width (in)	44.0	Yes	Ramp XSlope (%)	1.1
N/A	Flare Type LT	N/A	N/A	Flare Type RT	N/A
N/A	Flare Slope LT (%)	N/A	N/A	Flare Slope RT (%)	N/A
N/A	Flare Traversable LT?	N/A	N/A	Flare Traversable RT?	N/A
N/A	Landing Length (in)	N/A	N/A	DWS Provided?	N/A
N/A	Landing Width (in)	N/A	N/A	DWS Contrast?	N/A
N/A	Landing Slope (%)	N/A	N/A	DWS Length (in)	N/A
N/A	Landing X Slope (%)	N/A	N/A	DWS Full Width?	N/A
N/A	Landing Curb? (Y/N)	N/A	N/A	DWS Offset (in)	N/A
N/A	Shared Landing?	N/A			
N/A	Gutter Ponding?	N/A	N/A	Gutter Slope (%)	N/A
N/A	Gutter Lip Ht (in)	N/A	N/A	Gutter X Slope (%)	N/A
N/A	Painted X Walk1?	No	N/A	Painted X Walk2?	No

**Remove & Replace Curb Ramp With Two New Directional Ramps or Equivalent.**
