Access Compliance Report

Public Rights-of-Way

| Intersection ID: 9178 | Main Street: BEATTIES_FORD_RD | Cross Street: TATE_ST | Location: NE |
| ADA ID: 20162572B6BD | Ramp Type: Perp | Initial Pass/Fail: Fail | Overall Compliance: No |

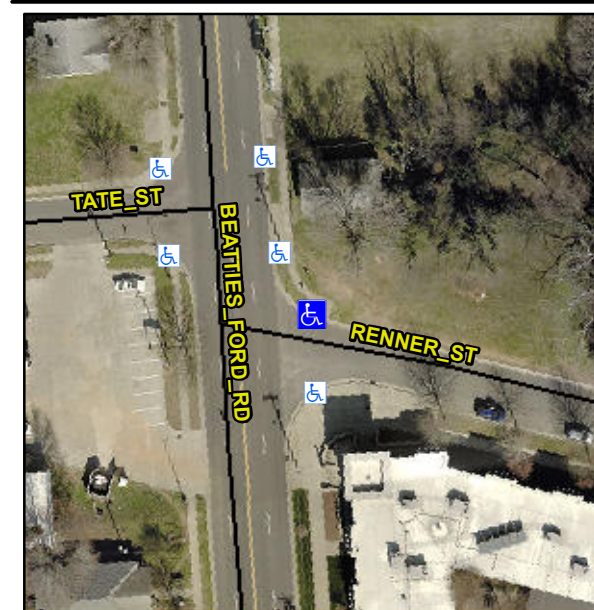
| Severity Score: 8.75 | | | |

Not Found, R304.5.1

| Compliance | Description | Data | Compliance | Description | Data |
|---|---|---|---|---|---|
| No | Ramp Width (in) | 42.0 | Yes | Ramp XSlope (%) | 1.5 |

Remove & Replace Entire Ramp.
