## Access Compliance Report Public Rights-of-Way (Curb Ramps)

Intersection ID: 4372
 Main Street: TRINITY\_RD
 Cross Street: LAKEVIEW\_RD
 Location:
 SE

ADA ID: 20AA1AC9CEDA
 Ramp Type: Perp
 Initial Pass/Fail: Fail
 Overall Compliance: No
 Severity Score:
 35

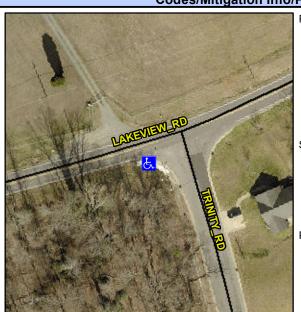
Not Found, R304.5.1, R304.2.2,
R304.5.3

Field Measurements/Component Compliance						
Comp	liance Description	Data	Comp	liance Description	Data	
N/A	Ramp Length (in)	58.0	No	Ramp Slope (%)	13.6	
No	Ramp Width (in)	44.5	No	Ramp XSlope (%)	4.9	
N/A	Flare Type LT	N/A	N/A	Flare Type RT	N/A	
N/A	Flare Slope LT (%)	N/A	N/A	Flare Slope RT (%)	N/A	
N/A	Flare Traversable LT?	N/A	N/A	Flare Traversable RT?	N/A	
N/A	Landing Length (in)	N/A	N/A	DWS Provided?	N/A	
N/A	Landing Width (in)	N/A	N/A	DWS Contrast?	N/A	
N/A	Landing Slope (%)	N/A	N/A	DWS Length (in)	N/A	
N/A	Landing X Slope (%)	N/A	N/A	DWS Full Width?	N/A	
N/A	Landing Curb? (Y/N)	N/A	N/A	DWS Offset (in)	N/A	
N/A	Shared Landing?	N/A				
N/A	Gutter Ponding?	N/A	N/A	Gutter Slope (%)	N/A	
N/A	Gutter Lip Ht (in)	2.0	N/A	Gutter X Slope (%)	N/A	
N/A	Painted X Walk1?	No	N/A	Painted X Walk2?	N/A	
	X Walk 1 Direction	To N		X Walk 2 Direction	N/A	
N/A	X Walk 1 Width (in)	N/A	N/A	X Walk 2 Width (in)	N/A	
	X Walk 1 Slope (%)	4.2		X Walk 2 Slope (%)	N/A

Remove & Replace Entire Ramp.
