| Intersection ID: 11229 | Main Street: DRUMMOND_AV | Cross Street: LYDIA_AV | Location: | SE |
| ADA ID: 20DC4702A07E | Ramp Type: Perp | Initial Pass/Fail: Fail | Overall Compliance: No | Severity Score: 26.25 |

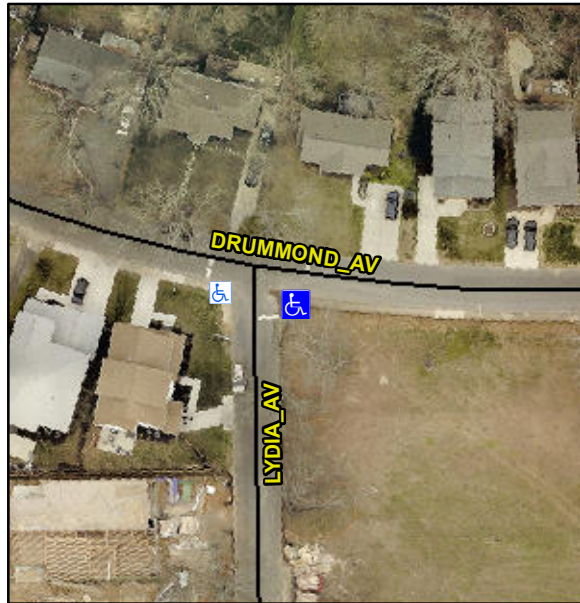
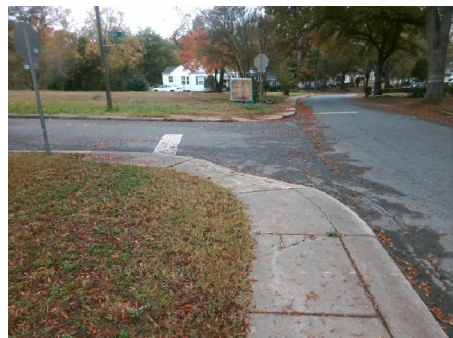
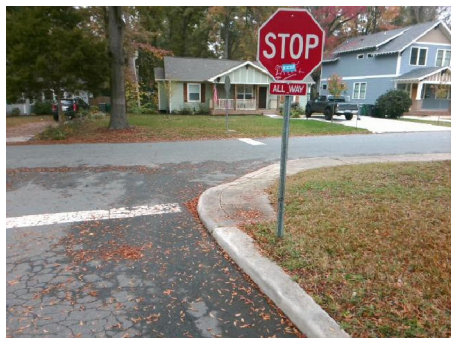
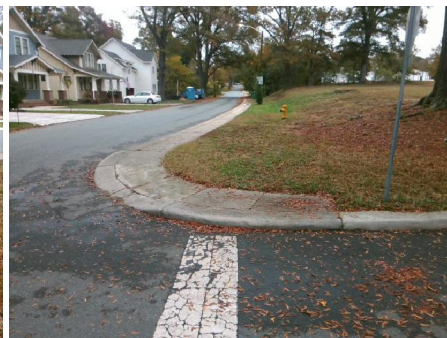
**Not Found, R304.2.2, R304.5.3**

| Possible Solutions: | | | Compliance | Description | Data | Compliance | Description | Data | | |
|---|--|--|---|---|---|---|---|---|--|--|
| <b>Remove &amp; Replace Entire Ramp.</b> | | | N/A | Ramp Length (in) | 38.5 | No | Ramp Slope (%) | 15.0 | | |
| | | | Yes | Ramp Width (in) | 58.0 | No | Ramp XSlope (%) | 2.9 | | |

### Remove & Replace Entire Ramp.
