# Access Compliance Report

## Public Rights-of-Way

### (Curb Ramps)

Intersection ID: 53962	Main Street: LILAC_TREE_AV	Cross Street: DENBUR_DR	Location: W
ADA ID: 20F0C4508813	Ramp Type: Perp	Initial Pass/Fail: Pass	Overall Compliance: No
Severity Score: 0.25			
Codes/Mitigation Info/Possible Solution		Field Measurements/Component Compliance

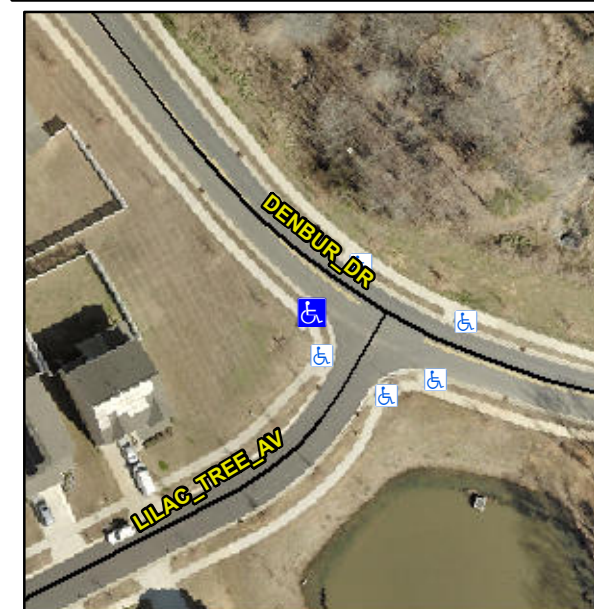
**Not Found, R304.5.3**

Compliance	Description	Data	Compliance	Description	Data
N/A	Ramp Length (in)	50.0	Yes	Ramp Slope (%)	6.6
Yes	Ramp Width (in)	48.0	No	Ramp XSlope (%)	2.1
N/A	Flare Type LT	Sloped	N/A	Flare Type RT	N/A
N/A	Flare Slope LT (%)	5.2	N/A	Flare Slope RT (%)	6.9
N/A	Flare Traversable LT?	No	N/A	Flare Traversable RT?	No
Yes	Landing Length (in)	59.5	Yes	DWS Provided?	Yes
Yes	Landing Width (in)	48.0	Yes	DWS Contrast?	Yes
Yes	Landing Slope (%)	1.2	Yes	DWS Length (in)	24.0
No	Landing X Slope (%)	2.6	Yes	DWS Full Width?	Yes
N/A	Landing Curb? (Y/N)	No	Yes	DWS Offset (in)	2.0
N/A	Shared Landing?	Yes			
Yes	Gutter Ponding?	No	Yes	Gutter Slope (%)	2.3
Yes	Gutter Lip Ht (in)	0.0	Yes	Gutter X Slope (%)	1.1
N/A	Painted X Walk1?	No	N/A	Painted X Walk2?	N/A
	X Walk 1 Direction	To NE		X Walk 2 Direction	N/A
N/A	X Walk 1 Width (in)	N/A	N/A	X Walk 2 Width (in)	N/A
	X Walk 1 Slope (%)	1.6		X Walk 2 Slope (%)	N/A
	X Walk 1 X Slope (%)	1.9		X Walk 2 X Slope (%)	N/A

N/A	Ramp inside XWalk1?	N/A	N/A	Ramp inside XWalk2?	N/A
	Road Slope (%)	N/A	N/A	Clear Space?	Yes
	Road X Slope (%)	N/A	N/A	Clear Space to XWalk (in)	N/A
Yes	Any Obstructions?	No	Yes	Storm Grate/Utility Hazard?	No
	Obstruction Type			Storm Grate/Utility Type	
		N/A			N/A
			Yes	Surface Condition? (G/P)	Good

**Remove & Replace Entire Ramp.**
