Access Compliance Report

Public Rights-of-Way

(Curb Ramps)

Intersection ID: 54402	Main Street: SPRINGMAN_LN	Cross Street: LOMA_LINDA_LN	Location: NW
ADA ID: 210F019DDDC9	Ramp Type: BlendTrans1	Initial Pass/Fail: Fail	Overall Compliance: No
		Severity Score: 8.75

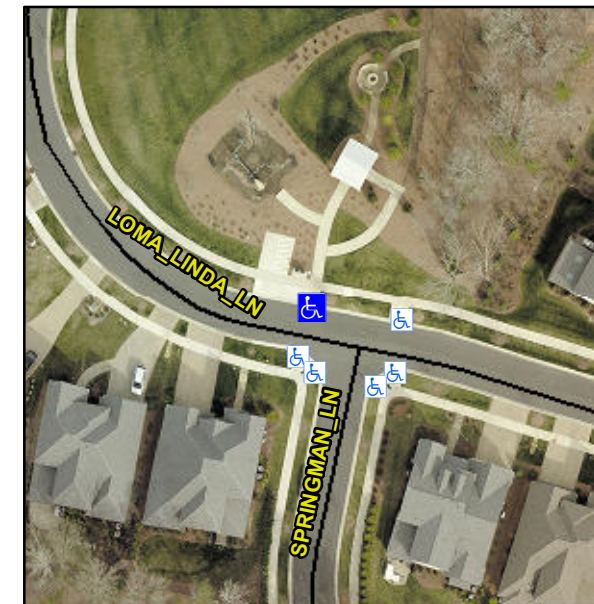
Not Found, R304.5.1

Compliance	Description	Data	Compliance	Description	Data
N/A	Ramp Length (in)	96.0	Yes	BlendTrans Slope (%)	3.2
No	Ramp Width (in)	45.5	Yes	BlendTrans XSlope (%)	1.5
N/A	Flare Type LT	N/A	N/A	Flare Type RT	N/A
N/A	Flare Slope LT (%)	N/A	N/A	Flare Slope RT (%)	N/A
N/A	Flare Traversable LT?	N/A	N/A	Flare Traversable RT?	N/A
N/A	Landing Length (in)	N/A	N/A	DWS Provided?	N/A
N/A	Landing Width (in)	N/A	N/A	DWS Contrast?	N/A
N/A	Landing Slope (%)	N/A	N/A	DWS Length (in)	N/A
N/A	Landing X Slope (%)	N/A	N/A	DWS Full Width?	N/A
N/A	Landing Curb? (Y/N)	N/A	N/A	DWS Offset (in)	N/A
N/A	Shared Landing?	N/A			
N/A	Gutter Ponding?	N/A	N/A	Gutter Slope (%)	N/A
N/A	Gutter Lip Ht (in)	N/A	N/A	Gutter X Slope (%)	N/A
N/A	Painted X Walk1?	No	N/A	Painted X Walk2?	N/A
	X Walk 1 Direction	To S		X Walk 2 Direction	N/A
	X Walk 1 Width (in)	N/A		X Walk 2 Width (in)	N/A
	X Walk 1 Slope (%)	2.7		X Walk 2 Slope (%)	N/A
	X Walk 1 X Slope (%)	2.3		X Walk 2 X Slope (%)	N/A

N/A	Ramp inside XWalk1?	N/A	N/A	Ramp inside XWalk2?	N/A
	Road Slope (%)	2.3		Clear Space?	N/A
	Road X Slope (%)	2.7	N/A	Clear Space to XWalk (in)	N/A
N/A	Any Obstructions?	N/A	N/A	Storm Grate/Utility Hazard?	N/A
	Obstruction Type			Storm Grate/Utility Type	
		N/A			N/A
			Yes	Surface Condition? (G/P)	Good
			No	Curb Slope (%)	18.6

Remove & Replace Curb Ramp With Two New Directional Ramps or Equivalent.
