## Access Compliance Report Public Rights-of-Way (Curb Ramps)

Intersection ID: 51369 Main Street: UNIVERSITY\_CITY\_BV Cross Street: IKEA\_BV Location: SW

ADA ID: 218F89C66CEE Ramp Type: Perp Initial Pass/Fail: Fail Overall Compliance: No Severity Score: 8.75

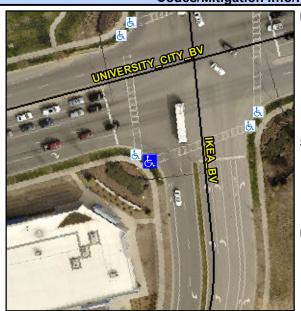
Comp	liance Description	Data	Comp	liance Description	Data
N/A	Ramp Length (in)	96.0	Yes	Ramp Slope (%)	8.0
No	Ramp Width (in)	47.5	Yes	Ramp XSlope (%)	0.6
N/A	Flare Type LT	N/A	N/A	Flare Type RT	N/A
N/A	Flare Slope LT (%)	N/A	N/A	Flare Slope RT (%)	N/A
N/A	Flare Traversable LT?	N/A	N/A	Flare Traversable RT?	N/A
N/A	Landing Length (in)	N/A	N/A	DWS Provided?	N/A
N/A	Landing Width (in)	N/A	N/A	DWS Contrast?	N/A
N/A	Landing Slope (%)	N/A	N/A	DWS Length (in)	N/A
N/A	Landing X Slope (%)	N/A	N/A	DWS Full Width?	N/A
N/A	Landing Curb? (Y/N)	N/A	N/A	DWS Offset (in)	N/A
N/A	Shared Landing?	N/A			
N/A	Gutter Ponding?	N/A	N/A	Gutter Slope (%)	N/A
N/A	Gutter Lip Ht (in)	N/A	N/A	Gutter X Slope (%)	N/A
N/A	Painted X Walk1?	Yes	N/A	Painted X Walk2?	N/A
	X Walk 1 Direction	To NE		X Walk 2 Direction	N/A
N/A	X Walk 1 Width (in)	80.0	N/A	X Walk 2 Width (in)	N/A
	X Walk 1 Slope (%)	0.1		X Walk 2 Slope (%)	N/A
	X Walk 1 X Slope (%)	1.6		X Walk 2 X Slope (%)	N/A

N/A	Ramp inside XWalk1?	Yes	N/A	Ramp inside XWalk2?	N/A
	Road Slope (%)	N/A	N/A	Clear Space?	N/A
	Road X Slope (%)	N/A	N/A	Clear Space to XWalk (in)	N/A
N/A	Any Obstructions?	N/A	N/A	Storm Grate/Utility Hazard?	N/A
	Obstruction Type			Storm Grate/Utility Type	
		N/A			N/A
			Yes	Surface Condition? (G/P)	Good

7551bic Goldtioli	
ossible Solutions:	Complia
Remove & Replace Entire Ramp.	N/A
•	No
	N/A
	N/A
	N/A
	N/A
urveyor Notes:	N/A
N/A	N/A
	N/A
	N/A
	N/A
ROW/ADA:	N/A
Not Found, R304.5.1	N/A
,	N/A
	N/A
	N/A

1850.00
