Access Compliance Report Public Rights-of-Way (Curb Ramps)

Intersection ID: 44684 Main Street: CEDAR CROFT DR Cross Street: LARRISA_CT Location: NW ADA ID: 21B1099100B9 Ramp Type: PerpDiag Initial Pass/Fail: Fail **Overall Compliance: No Severity Score:** 55

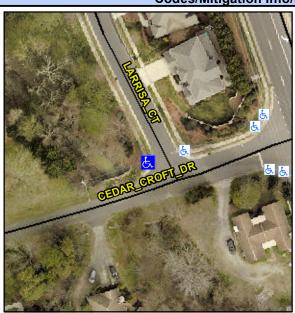
Possible Solutions: Remove & Replace Curb Ramp With **Two New Directional Ramps or** Equivalent. Surveyor Notes: N/A PROW/ADA: Not Found, R304.5.1, R304.2.2,

R304.5.3

Field Measurements/Component Compliance					
Compliance Description		Data	Comp	liance Description	Data
N/A	Ramp Length (in)	49.0	No	Ramp Slope (%)	11.5
No	Ramp Width (in)	35.0	No	Ramp XSlope (%)	9.0
N/A	Flare Type LT	N/A	N/A	Flare Type RT	N/A
N/A	Flare Slope LT (%)	N/A	N/A	Flare Slope RT (%)	N/A
N/A	Flare Traversable LT?	N/A	N/A	Flare Traversable RT?	N/A
N/A	Landing Length (in)	N/A	N/A	DWS Provided?	N/A
N/A	Landing Width (in)	N/A	N/A	DWS Contrast?	N/A
N/A	Landing Slope (%)	N/A	N/A	DWS Length (in)	N/A
N/A	Landing X Slope (%)	N/A	N/A	DWS Full Width?	N/A
N/A	Landing Curb? (Y/N)	N/A	N/A	DWS Offset (in)	N/A
N/A	Shared Landing?	N/A			
N/A	Gutter Ponding?	N/A	N/A	Gutter Slope (%)	N/A
N/A	Gutter Lip Ht (in)	N/A	N/A	Gutter X Slope (%)	N/A
N/A	Painted X Walk1?	No	N/A	Painted X Walk2?	No
	X Walk 1 Direction	To S		X Walk 2 Direction	To E
N/A	X Walk 1 Width (in)	N/A	N/A	X Walk 2 Width (in)	N/A
	X Walk 1 Slope (%)	0.7		X Walk 2 Slope (%)	8.0

X Walk 1 X Slope (%)	9.9		X Walk 2 X Slope (%)	1.5
N/A	Ramp inside XWalk1?	N/A	N/A	Ramp inside XWalk2?	N/A
	Road Slope (%)	7.2	N/A	Clear Space?	N/A
	Road X Slope (%)	8.2	N/A	Clear Space to XWalk (in)	N/A
N/A	Any Obstructions?	N/A	N/A	Storm Grate/Utility Hazard?	N/A
	Obstruction Type			Storm Grate/Utility Type	
		N/A			N/A
			Yes	Surface Condition? (G/P)	Good
