Access Compliance Report Public Rights-of-Way (Curb Ramps)

Intersection ID: 12849 Main Street: E_MARTIN_LUTHER_KING_JR_GBVss Street: S_BREVARD_ST Location: SE

ADA ID: 21B924F0F0EC Ramp Type: Perp Initial Pass/Fail: Fail Overall Compliance: No Severity Score: 12.5

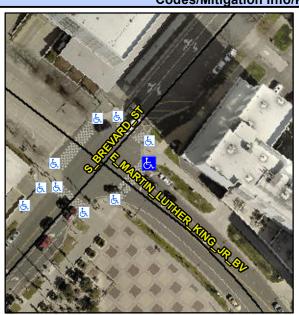
Field Measurements/Component Compliance						
Comp	liance Description	Data	Comp	liance Description	Data	
N/A	Ramp Length (in)	78.0	Yes	Ramp Slope (%)	6.1	
Yes	Ramp Width (in)	48.0	No	Ramp XSlope (%)	5.2	
N/A	Flare Type LT	N/A	N/A	Flare Type RT	N/A	
N/A	Flare Slope LT (%)	N/A	N/A	Flare Slope RT (%)	N/A	
N/A	Flare Traversable LT?	N/A	N/A	Flare Traversable RT?	N/A	
N/A	Landing Length (in)	N/A	N/A	DWS Provided?	N/A	
N/A	Landing Width (in)	N/A	N/A	DWS Contrast?	N/A	
N/A	Landing Slope (%)	N/A	N/A	DWS Length (in)	N/A	
N/A	Landing X Slope (%)	N/A	N/A	DWS Full Width?	N/A	
N/A	Landing Curb? (Y/N)	N/A	N/A	DWS Offset (in)	N/A	
N/A	Shared Landing?	N/A				
N/A	Gutter Ponding?	N/A	N/A	Gutter Slope (%)	N/A	
N/A	Gutter Lip Ht (in)	N/A	N/A	Gutter X Slope (%)	N/A	
N/A	Painted X Walk1?	Yes	N/A	Painted X Walk2?	N/A	
	X Walk 1 Direction	To SW		X Walk 2 Direction	N/A	
N/A	X Walk 1 Width (in)	144.0	N/A	X Walk 2 Width (in)	N/A	
	X Walk 1 Slope (%)	1.7		X Walk 2 Slope (%)	N/A

X Walk 1 X Slope (%)	3.9		X Walk 2 X Slope (%)	N/A	
N/A	Ramp inside XWalk1?	Yes	N/A	Ramp inside XWalk2?	N/A	
	Road Slope (%)	N/A	N/A	Clear Space?	N/A	
	Road X Slope (%)	N/A	N/A	Clear Space to XWalk (in)	N/A	
N/A	Any Obstructions?	N/A	N/A	Storm Grate/Utility Hazard?	N/A	
	Obstruction Type			Storm Grate/Utility Type		
		N/A			N/A	
			Yes	Surface Condition? (G/P)	Good

1055IDIE GOIULIOII		
Possible Solutions:	Co	
Remove & Replace Entire Ramp.		
•	Ye	
	N/	
Surveyor Notes:	N/	
N/A	N/	
	N/	
	N/	
	N/	
PROW/ADA:	N/	
Not Found, R304.5.3	N/	
	N/	
	N/

Total Cost: \$ 1850.00
