Access Compliance Report Public Rights-of-Way (Curb Ramps)

Intersection ID: 31771Main Street:STARNES_RANDALL_RDCross Street:PINYON_PINE_LNLocation:SEADA ID: 2283CD852890Ramp Type:PerpInitial Pass/Fail:FailOverall Compliance:NoSeverity Score:35

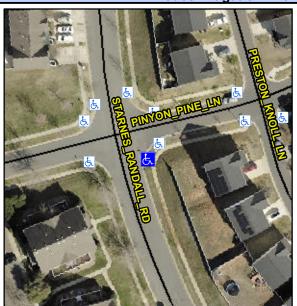
Compl	iance Description	Data	Comp	liance	Description	Data
N/A	Ramp Length (in)	91.0	Yes	Ramp	Slope (%)	7.1
No	Ramp Width (in)	24.0	Yes	Ramp	XSlope (%)	1.4
N/A	Flare Type LT	N/A	N/A	Flare	Type RT	N/A
N/A	Flare Slope LT (%)	N/A	N/A	Flare	Slope RT (%)	N/A
N/A	Flare Traversable LT?	N/A	N/A	Flare	Traversable RT?	N/A
N/A	Landing Length (in)	N/A	N/A	DWS Provided?		N/A
N/A	Landing Width (in)	N/A	N/A	DWS Contrast?		N/A
N/A	Landing Slope (%)	N/A	N/A	DWS	Length (in)	N/A
N/A	Landing X Slope (%)	N/A	N/A	DWS	Full Width?	N/A
N/A	Landing Curb? (Y/N)	N/A	N/A	DWS	Offset (in)	N/A
N/A	Shared Landing?	N/A				
N/A	Gutter Ponding?	N/A	N/A	Gutte	r Slope (%)	N/A
N/A	Gutter Lip Ht (in)	N/A	N/A	Gutte	r X Slope (%)	N/A
N/A	Painted X Walk1?	No	N/A	Paint	ed X Walk2?	N/A
	X Walk 1 Direction	To W		X Wa	lk 2 Direction	N/A
N/A	X Walk 1 Width (in)	N/A	N/A	X Wa	lk 2 Width (in)	N/A
	X Walk 1 Slope (%)	2.4		X Wa	lk 2 Slope (%)	N/A
	X Walk 1 X Slope (%)	2.2		X Wa	lk 2 X Slope (%)	N/A

Possible Solutions:	Co
Remove & Replace Entire Ramp.	N/A
·	No
	N/A
	N/A
	N/A
	N/A
Surveyor Notes:	N/A
N/A	N/A
	N/A
	N/A
	N/A
PROW/ADA:	N/A
Not Found, R304.5.1	N/A
	N/A
	N/A
	N
