# Access Compliance Report

## Public Rights-of-Way

### (Curb Ramps)

| Intersection ID: 50581 | Main Street: PAPER_TREE_RD | Cross Street: GRAND_FIR_RD | Location: NE |

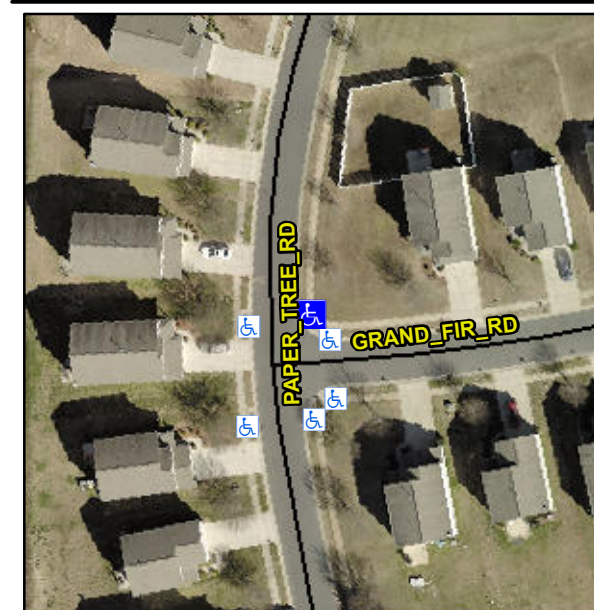
| ADA ID: 22BEAE890462 | Ramp Type: Perp | Initial Pass/Fail: Fail | Overall Compliance: No |
| Severity Score: 8.75 | | | |

**R304.5.1**

| Compliance | Description | Data | Compliance | Description | Data |
|---|---|---|---|---|---|
| No | Ramp Width (in) | 47.0 | Yes | Ramp XSlope (%) | 1.8 |

**Remove & Replace Entire Ramp.**
