Access Compliance Report

Public Rights-of-Way

(Curb Ramps)

Intersection ID: 11799	Main Street: MECKLENBURG_AV	Cross Street: NORCROSS_PL	Location: SW
ADA ID: 22C6E9608D2D	Ramp Type: Directional1	Initial Pass/Fail: Fail	Overall Compliance: No
			Severity Score: 13.75

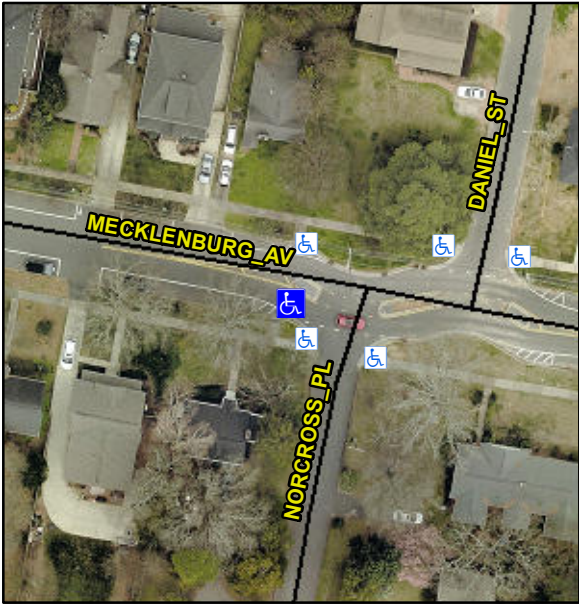
<div>Street 1 Name<div>MECKLENBURG AV</div></div> <div>Stop Condition-Street 1<div>None</div></div> <div>Street 2 Name<div>N/A</div></div> <div>Stop Condition-Street 2<div>N/A</div></div>	Possible Solutions:		Compliance			Compliance		
	Remove & Replace Entire Ramp.		N/A	Ramp Length (in)	109.0	N/A	Grade Break?	N/A
			Yes	Ramp Width (in)	59.0	N/A	Grade Break Slope (%)	0.0
			No	Ramp Slope (%)	8.7	N/A	Grade Break XSlope (%)	0.0
			No	Ramp XSlope (%)	3.4			
			N/A	Flare Type LT	N/A	N/A	Flare Type RT	N/A
			N/A	Flare Slope LT (%)	N/A	N/A	Flare Slope RT (%)	0.0
			N/A	Flare Traversable LT?	N/A	N/A	Flare Traversable RT?	N/A
	Surveyor Notes:		N/A	Landing Length (in)	0.0	N/A	DWS Provided?	N/A
				N/A	Landing Width (in)	0.0	N/A	DWS Contrast?
			N/A	Landing Slope (%)	0.0	N/A	DWS Length (in)	N/A
			N/A	Landing X Slope (%)	0.0	N/A	DWS Full Width?	N/A

PROW/ADA:			N/A	Landing Curb? (Y/N)	N/A	N/A	DWS Offset LT (in)	N/A
R304.2.2, R304.5.3			N/A	Shared Landing?	N/A	N/A	DWS Offset RT (in)	N/A
			N/A	Gutter Ponding?	0.0	N/A	Gutter Slope (%)	N/A
			N/A	Gutter Lip Ht (in)	0.0	N/A	Gutter X Slope (%)	N/A
			N/A	Painted X Walk1?	No		Road Slope (%)	3.6
				X Walk 1 Direction	To N		Road X Slope (%)	3.0
				X Walk 1 Width (in)	N/A		Clear Space?	N/A
				X Walk 1 Slope (%)	3.6	N/A	Clear Space to XWalk (in)	N/A
				X Walk 1 X Slope (%)	3.0	N/A	Storm Grate/Utility Hazard?	N/A
			N/A	Ramp inside XWalk1?	N/A		Storm Grate/Utility Type	
			N/A	Any Obstructions?	N/A			N/A
				Obstruction Type		Yes	Surface Condition? (G/P)	Good
						N/A	Curb Slope (%)	7.6
Total Cost:		\$ 1600.00
