# Access Compliance Report

## Public Rights-of-Way

| Intersection ID: 11730 | Main Street: MECKLENBURG_AV | Cross Street: THE_PLAZA | Location: NW |
| ADA ID: 232BBC8BAA19 | Ramp Type: Para | Initial Pass/Fail: Fail | Overall Compliance: No |

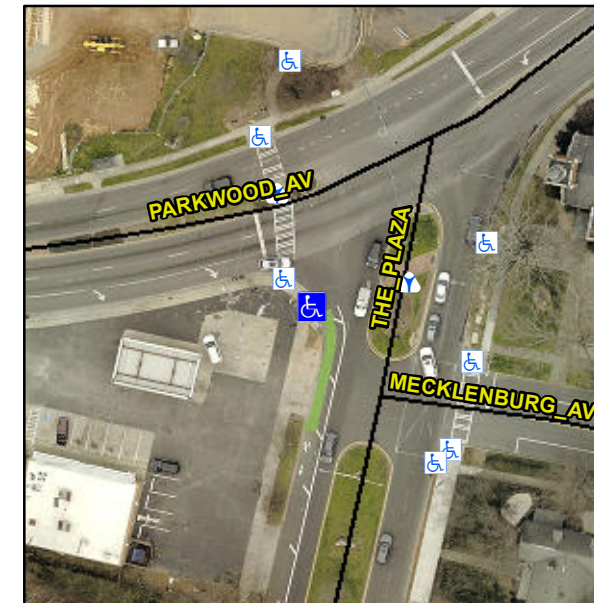
| | | | Severity Score: 13.75 |

**LT RP < 5%**

**R304.5.3, R304.3.2**

| Compliance | Description | Data | Compliance | Description | Data |
|---|---|---|---|---|---|
| Yes | Ramp Slope LT (%) | 1.4 | No | Ramp Slope RT (%) | 10.8 |
| No | Ramp XSlope LT (%) | 5.0 | No | Ramp XSlope RT (%) | 2.8 |

**Remove & Replace Entire Ramp.**
