# Access Compliance Report

## Public Rights-of-Way

| Intersection ID: 20517 | Main Street: PARK_SOUTH_DR | Cross Street: WOODBINE_LN | Location: SW |
| ADA ID: 237CEDE59DEB | Ramp Type: PerpDiag | Initial Pass/Fail: Fail | Overall Compliance: No |

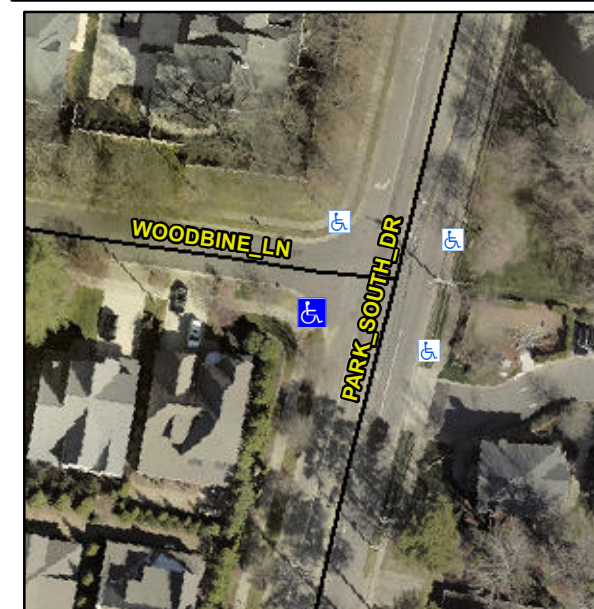
**Not Found, R304.5.1, R304.2.2, R304.5.3**

| Compliance | Description | Data | Compliance | Description | Data |
|---|---|---|---|---|---|
| N/A | Ramp Length (in) | 95.0 | No | Ramp Slope (%) | 10.1 |
| No | Ramp Width (in) | 36.0 | No | Ramp XSlope (%) | 9.1 |

**Remove & Replace Curb Ramp With Two New Directional Ramps or Equivalent.**
