# Access Compliance Report

## Public Rights-of-Way

### (Curb Ramps)

| Intersection ID: 53380 | Main Street: IKEA_BV | Cross Street: LEWIS_ST | Location: E |

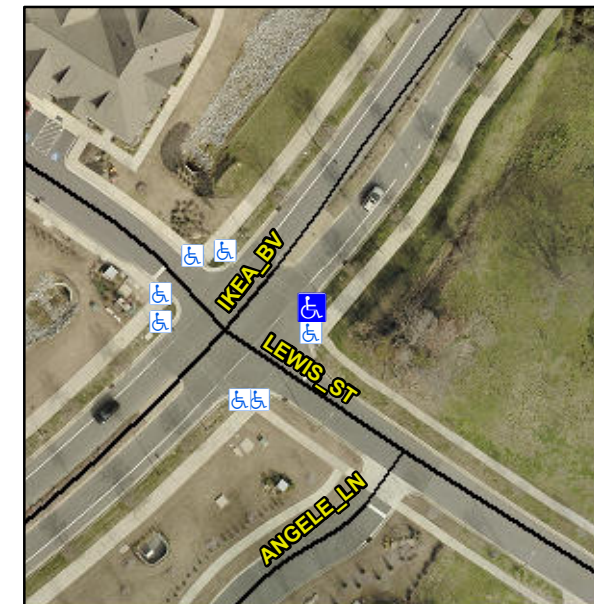
**Not Found, R305.2, R302.7**

| Compliance | Description | Data | Compliance | Description | Data |
|---|---|---|---|---|---|
| N/A | Landing Curb? (Y/N) | No | No | DWS Offset (in) | 3.3 |
| No | Gutter Ponding? | Yes | Yes | Gutter Slope (%) | 4.2 |
| | | | No | Curb Slope (%) | 10.0 |

**Remove & Replace Curb Ramp With Two New Directional Ramps or Equivalent.**
