# Access Compliance Report

## Public Rights-of-Way

### (Curb Ramps)

Intersection ID: 10038458	Main Street: SOUTHERN_PINE_BV	Cross Street: N/A	Location: S
ADA ID: 2438160C8C52	Ramp Type: PerpDiag	Initial Pass/Fail: Fail	Overall Compliance: No
Severity Score: 37.5			
Codes/Mitigation Info/Possible Solution		Field Measurements/Component Compliance

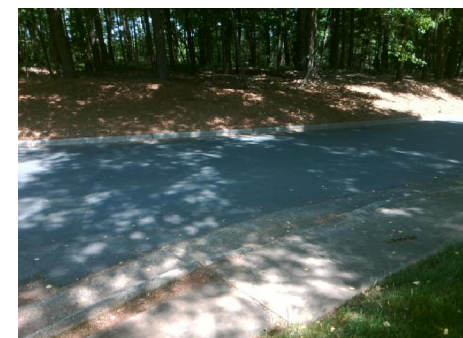
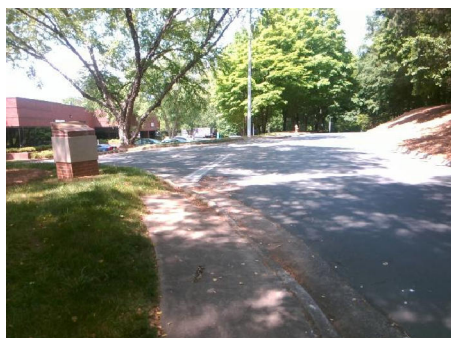
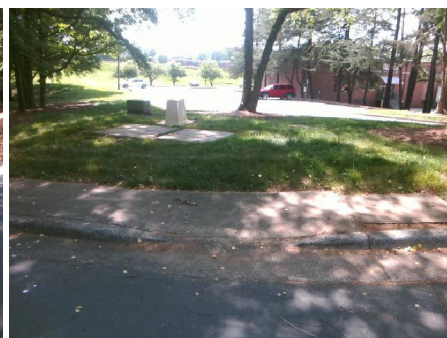
**Not Found, R304.2.2, R304.5.3**

Compliance	Description	Data	Compliance	Description	Data
N/A	Ramp Length (in)	48.0	No	Ramp Slope (%)	9.3
Yes	Ramp Width (in)	48.0	No	Ramp XSlope (%)	7.6
N/A	Flare Type LT	N/A	N/A	Flare Type RT	N/A
N/A	Flare Slope LT (%)	N/A	N/A	Flare Slope RT (%)	N/A
N/A	Flare Traversable LT?	N/A	N/A	Flare Traversable RT?	N/A
N/A	Landing Length (in)	N/A	N/A	DWS Provided?	N/A
N/A	Landing Width (in)	N/A	N/A	DWS Contrast?	N/A
N/A	Landing Slope (%)	N/A	N/A	DWS Length (in)	N/A
N/A	Landing X Slope (%)	N/A	N/A	DWS Full Width?	N/A
N/A	Landing Curb? (Y/N)	N/A	N/A	DWS Offset (in)	N/A
N/A	Shared Landing?	N/A			
N/A	Gutter Ponding?	N/A	N/A	Gutter Slope (%)	N/A
N/A	Gutter Lip Ht (in)	N/A	N/A	Gutter X Slope (%)	N/A
N/A	Painted X Walk1?	No	N/A	Painted X Walk2?	No
	X Walk 1 Direction	To N		X Walk 2 Direction	To W
N/A	X Walk 1 Width (in)	N/A	N/A	X Walk 2 Width (in)	N/A
	X Walk 1 Slope (%)	1.6		X Walk 2 Slope (%)	6.4
	X Walk 1 X Slope (%)	5.4		X Walk 2 X Slope (%)	6.2

**Remove & Replace Curb Ramp With Two New Directional Ramps or Equivalent.**

Total Cost: \$ 3200.00
