## Access Compliance Report Public Rights-of-Way (Curb Ramps)

Intersection ID: 47846 Main Street: ALVARADO\_WY Cross Street: STONE\_PORCH\_RD Location: SW

ADA ID: 245599729002 Ramp Type: PerpDiag Initial Pass/Fail: Fail Overall Compliance: No Severity Score: 33.75

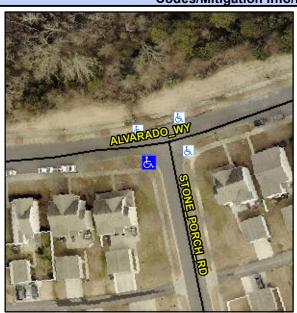
Not Found, R304.5.1, R304.5.3

Field Measurements/Component Compliance					
Compliance Description		Data	Compliance Description		Data
N/A	Ramp Length (in)	74.0	Yes	Ramp Slope (%)	7.2
No	Ramp Width (in)	46.0	No	Ramp XSlope (%)	7.0
N/A	Flare Type LT	N/A	N/A	Flare Type RT	N/A
N/A	Flare Slope LT (%)	N/A	N/A	Flare Slope RT (%)	N/A
N/A	Flare Traversable LT?	N/A	N/A	Flare Traversable RT?	N/A
N/A	Landing Length (in)	N/A	N/A	DWS Provided?	N/A
N/A	Landing Width (in)	N/A	N/A	DWS Contrast?	N/A
N/A	Landing Slope (%)	N/A	N/A	DWS Length (in)	N/A
N/A	Landing X Slope (%)	N/A	N/A	DWS Full Width?	N/A
N/A	Landing Curb? (Y/N)	N/A	N/A	DWS Offset (in)	N/A
N/A	Shared Landing?	N/A			
N/A	Gutter Ponding?	N/A	N/A	Gutter Slope (%)	N/A
N/A	Gutter Lip Ht (in)	N/A	N/A	Gutter X Slope (%)	N/A
N/A	Painted X Walk1?	No	N/A	Painted X Walk2?	No
	X Walk 1 Direction	To E		X Walk 2 Direction	To N
N/A	X Walk 1 Width (in)	N/A	N/A	X Walk 2 Width (in)	N/A
	X Walk 1 Slope (%)	0.5		X Walk 2 Slope (%)	2.2

X Walk 1 X Slope (%)	0.0		X Walk 2 X Slope (%)	0.9
N/A	Ramp inside XWalk1?	N/A	N/A	Ramp inside XWalk2?	N/A
	Road Slope (%)	0.8	N/A	Clear Space?	N/A
	Road X Slope (%)	0.4	N/A	Clear Space to XWalk (in)	N/A
N/A	Any Obstructions?	N/A	N/A	Storm Grate/Utility Hazard?	N/A
	Obstruction Type			Storm Grate/Utility Type	
		N/A			N/A
			Yes	Surface Condition? (G/P)	Good
The Marie I

Remove & Replace Curb Ramp With
Two New Directional Ramps or
Equivalent.
