## Access Compliance Report Public Rights-of-Way (Curb Ramps)

Intersection ID: 3233Main Street:HERITAGE\_HILLS\_LNCross Street:PROSPERITY\_CHURCH\_RDLocation:NWADA ID: 245ECF1C2B01Ramp Type:ParaInitial Pass/Fail:FailOverall Compliance:NoSeverity Score:13.75

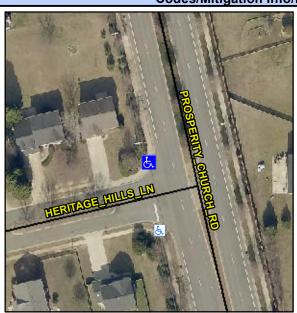
Field Measurements/Component Compliance							
Comp	liance Description	Data	Comp	liance Description	Data		
N/A	Ramp Length LT (in)	64.0	N/A	Ramp Length RT (in)	56.0		
Yes	Ramp Width LT (in)	71.0	Yes	Ramp Width RT (in)	71.0		
Yes	Ramp Slope LT (%)	7.6	No	Ramp Slope RT (%)	10.2		
Yes	Ramp XSlope LT (%)	1.1	No	Ramp XSlope RT (%)	3.4		
N/A	Landing Length (in)	N/A	N/A	DWS Provided?	N/A		
N/A	Landing Width (in)	N/A	N/A	DWS Contrast?	N/A		
N/A	Landing Slope (%)	N/A	N/A	DWS Length (in)	N/A		
N/A	Landing X Slope (%)	N/A	N/A	DWS Full Width?	N/A		
N/A	Landing Curb? (Y/N)	N/A	N/A	DWS Offset (in)	N/A		
N/A	Shared Landing?	N/A					
N/A	Gutter Ponding?	N/A	N/A	Gutter Slope (%)	N/A		
N/A	Gutter Lip Ht (in)	N/A	N/A	Gutter X Slope (%)	N/A		
N/A	Painted X Walk1?	No	N/A	Painted X Walk2?	N/A		
	X Walk 1 Direction	To E		X Walk 2 Direction	N/A		
N/A	X Walk 1 Width (in)	N/A	N/A	X Walk 2 Width (in)	N/A		
	X Walk 1 Slope (%)	2.4		X Walk 2 Slope (%)	N/A

X Walk 1 X Slope (%)	3.5		X Walk 2 X Slope (%)	N/A		
N/A	Ramp inside XWalk1?	N/A	N/A	Ramp inside XWalk2?	N/A		
	Road Slope (%)	N/A	N/A	Clear Space?	N/A		
	Road X Slope (%)	N/A	N/A	Clear Space to XWalk (in)	N/A		
N/A	Any Obstructions?	N/A	N/A	Storm Grate/Utility Hazard?	N/A		
	Obstruction Type			Storm Grate/Utility Type			
		N/A			N/A		
			Yes	Surface Condition? (G/P)	Good		
			N/A	Curb Slope (%)	11.2		
qour by

i ossible solution	
Possible Solutions:	
Remove & Replace Entire Ramp.	ľ
•	١
	١
	١
	ı
	N
Surveyor Notes:	M
N/A	ı
	N
	ı
	N
PROW/ADA:	N
R304.3.2, R304.5.3	ı
	ľ
