# Access Compliance Report

## Public Rights-of-Way

### (Curb Ramps)

Intersection ID: 11236	Main Street: N_CHURCH_ST	Cross Street: W_LIDDELL_ST	Location: S
ADA ID: 2492F6872CA8	Ramp Type: ParaDiag	Initial Pass/Fail: Fail	Overall Compliance: No
Codes/Mitigation Info/Possible Solution		Field Measurements/Component Compliance	
Severity Score: 28.75

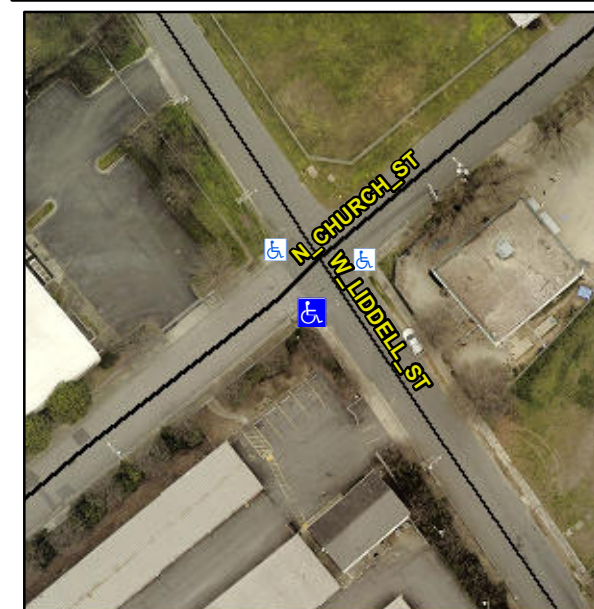
**DAMAGED RT RAMP**

**R304.5.3, R304.3.2, R302.7**

Compliance	Description	Data	Compliance	Description	Data
N/A	Ramp Length LT (in)	73.5	N/A	Ramp Length RT (in)	60.5
Yes	Ramp Width LT (in)	71.5	Yes	Ramp Width RT (in)	59.5
Yes	Ramp Slope LT (%)	5.7	No	Ramp Slope RT (%)	9.8
No	Ramp XSlope LT (%)	3.2	Yes	Ramp XSlope RT (%)	0.3
N/A	Landing Length (in)	N/A	N/A	DWS Provided?	N/A
N/A	Landing Width (in)	N/A	N/A	DWS Contrast?	N/A
N/A	Landing Slope (%)	N/A	N/A	DWS Length (in)	N/A
N/A	Landing X Slope (%)	N/A	N/A	DWS Full Width?	N/A
N/A	Landing Curb? (Y/N)	N/A	N/A	DWS Offset (in)	N/A
N/A	Shared Landing?	N/A			
N/A	Gutter Ponding?	N/A	N/A	Gutter Slope (%)	N/A
N/A	Gutter Lip Ht (in)	N/A	N/A	Gutter X Slope (%)	N/A
N/A	Painted X Walk1?	No	N/A	Painted X Walk2?	No
	X Walk 1 Direction	To NE		X Walk 2 Direction	To NW
N/A	X Walk 1 Width (in)	N/A	N/A	X Walk 2 Width (in)	N/A
	X Walk 1 Slope (%)	0.6		X Walk 2 Slope (%)	2.9
	X Walk 1 X Slope (%)	4.5		X Walk 2 X Slope (%)	1.0
N/A	Ramp inside XWalk1?	N/A	N/A	Ramp inside XWalk2?	N/A

Road Slope (%)	4.0	N/A	Clear Space?	N/A
	Road X Slope (%)	5.6	N/A	Clear Space to XWalk (in)	N/A
N/A	Any Obstructions?	N/A	N/A	Storm Grate/Utility Hazard?	N/A
	Obstruction Type			Storm Grate/Utility Type	
		N/A			N/A
			No	Surface Condition? (G/P)	Poor
			N/A	Curb Slope (%)	13.2

**Remove & Replace Curb Ramp With Two New Directional Ramps or Equivalent.**
