Access Compliance Report Public Rights-of-Way (Curb Ramps)

Intersection ID: N/AMain Street: KELBURN_LNCross Street: N/ALocation:EADA ID: 249B1DC7C675Ramp Type: PerpInitial Pass/Fail: FailOverall Compliance: NoSeverity Score:10

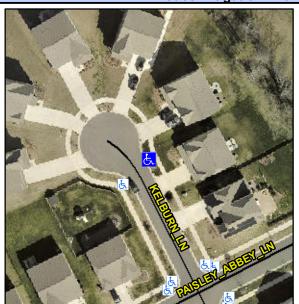
R304.5.1, R304.5.3

Field Measurements/Component Compliance					
Compliance Description		Data	Comp	liance Description	Data
N/A	Ramp Length (in)	96.0	Yes	Ramp Slope (%)	5.6
No	Ramp Width (in)	46.5	No	Ramp XSlope (%)	3.6
N/A	Flare Type LT	N/A	N/A	Flare Type RT	N/A
N/A	Flare Slope LT (%)	N/A	N/A	Flare Slope RT (%)	N/A
N/A	Flare Traversable LT?	N/A	N/A	Flare Traversable RT?	N/A
N/A	Landing Length (in)	N/A	N/A	DWS Provided?	N/A
N/A	Landing Width (in)	N/A	N/A	DWS Contrast?	N/A
N/A	Landing Slope (%)	N/A	N/A	DWS Length (in)	N/A
N/A	Landing X Slope (%)	N/A	N/A	DWS Full Width?	N/A
N/A	Landing Curb? (Y/N)	N/A	N/A	DWS Offset (in)	N/A
N/A	Shared Landing?	N/A			
N/A	Gutter Ponding?	N/A	N/A	Gutter Slope (%)	N/A
N/A	Gutter Lip Ht (in)	N/A	N/A	Gutter X Slope (%)	N/A
N/A	Painted X Walk1?	No	N/A	Painted X Walk2?	N/A
	X Walk 1 Direction	To SW		X Walk 2 Direction	N/A
N/A	X Walk 1 Width (in)	N/A	N/A	X Walk 2 Width (in)	N/A
	X Walk 1 Slope (%)	4.3		X Walk 2 Slope (%)	N/A

X Walk 1 X Slope (%)	2.0		X Walk 2 X Slope (%)	N/A
N/A	Ramp inside XWalk1?	N/A	N/A	Ramp inside XWalk2?	N/A
	Road Slope (%)	N/A	N/A	Clear Space?	N/A
	Road X Slope (%)	N/A	N/A	Clear Space to XWalk (in)	N/A
N/A	Any Obstructions?	N/A	N/A	Storm Grate/Utility Hazard?	N/A
	Obstruction Type			Storm Grate/Utility Type	
		N/A			N/A
			Yes	Surface Condition? (G/P)	Good
	田何用

Remove & Replace Entire Ramp.
