# Access Compliance Report

## Public Rights-of-Way

| Intersection ID: 27738 | Main Street: JAMES JACK LN | Cross Street: VILLALONGA LN | Location: NW |
| ADA ID: 24C0F00BF670 | Ramp Type: PerpDiag | Initial Pass/Fail: Fail | Overall Compliance: No |

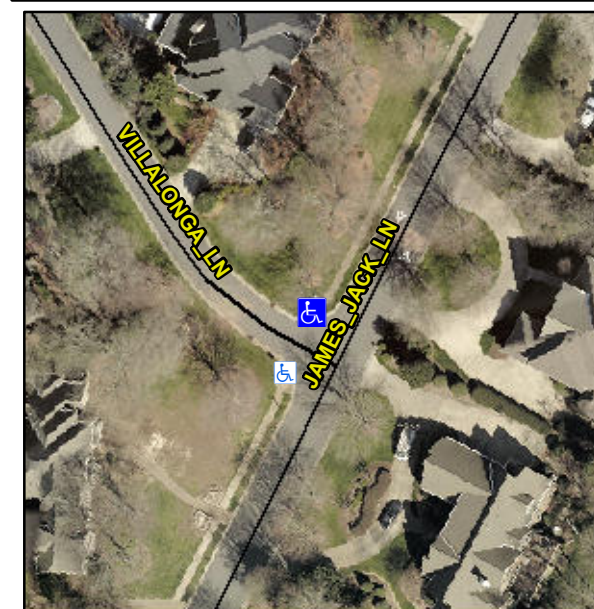
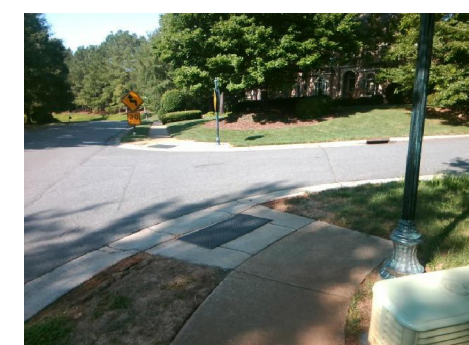
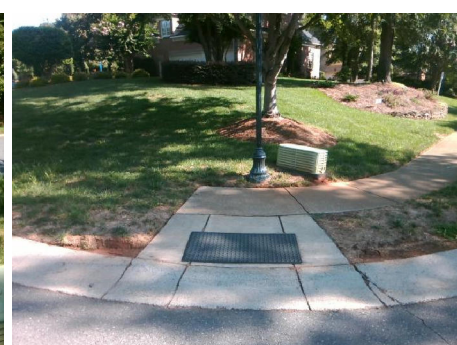
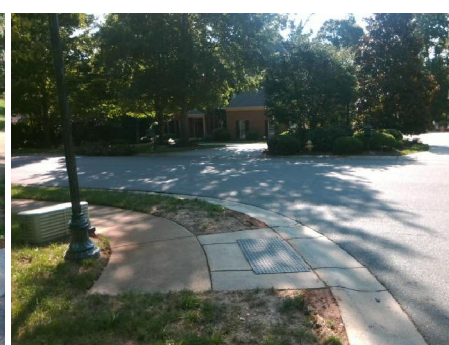
| Severity Score: 10 | | | |

**Not Found, R304.5.1, R304.5.3**

| Compliance | Description | Data | Compliance | Description | Data |
|---|---|---|---|---|---|
| No | Ramp Width (in) | 36.0 | No | Ramp XSlope (%) | 4.2 |

**Remove & Replace Curb Ramp With Two New Directional Ramps or Equivalent.**
