Intersection ID: 42983	Main Street: CHRUDAN_DR	Cross Street: LADORA_DR	Location:	E
ADA ID: 24CB2A6110C1	Ramp Type: PerpDiag	Initial Pass/Fail: Fail	Overall Compliance: No	Severity Score: 46.25

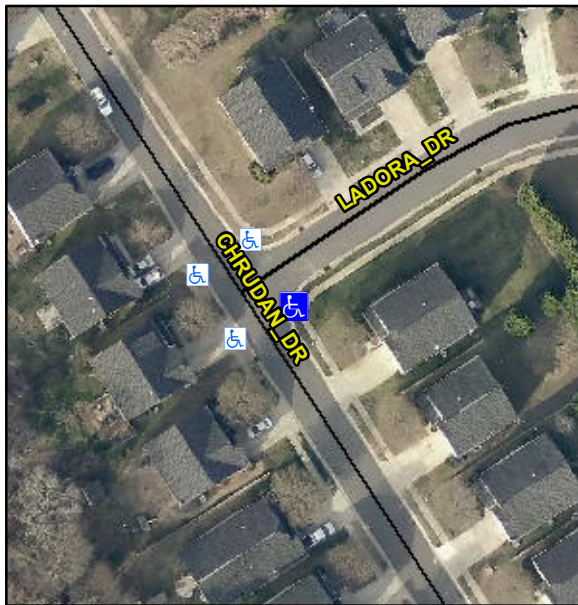
**Not Found, R304.5.1, R304.2.2,
R304.5.3**

Possible Solutions:		Compliance	Description	Data	Compliance	Description	Data
Remove & Replace Curb Ramp With Two New Directional Ramps or Equivalent.	N/A	Ramp Length (in)	46.5	No	Ramp Slope (%)	11.1	
	No	Ramp Width (in)	37.0	No	Ramp XSlope (%)	14.0	
	N/A	Flare Type LT	N/A	N/A	Flare Type RT	N/A	
	N/A	Flare Slope LT (%)	N/A	N/A	Flare Slope RT (%)	N/A	
	N/A	Flare Traversable LT?	N/A	N/A	Flare Traversable RT?	N/A	
	N/A	Landing Length (in)	N/A	N/A	DWS Provided?	N/A	
	N/A	Landing Width (in)	N/A	N/A	DWS Contrast?	N/A	
	N/A	Landing Slope (%)	N/A	N/A	DWS Length (in)	N/A	
	N/A	Landing X Slope (%)	N/A	N/A	DWS Full Width?	N/A	
	N/A	Landing Curb? (Y/N)	N/A	N/A	DWS Offset (in)	N/A	
Surveyor Notes: N/A	N/A	Shared Landing?	N/A				
	N/A	Gutter Ponding?	N/A	N/A	Gutter Slope (%)	N/A	
	N/A	Gutter Lip Ht (in)	N/A	N/A	Gutter X Slope (%)	N/A	
	N/A	Painted X Walk1?	No	N/A	Painted X Walk2?	No	
		X Walk 1 Direction	To NW		X Walk 2 Direction	To SW

N/A	X Walk 1 Width (in)	N/A	N/A	X Walk 2 Width (in)	N/A	
		X Walk 1 Slope (%)	5.4		X Walk 2 Slope (%)	3.0	
		X Walk 1 X Slope (%)	8.8		X Walk 2 X Slope (%)	9.1	
	N/A	Ramp inside XWalk1?	N/A	N/A	Ramp inside XWalk2?	N/A	
		Road Slope (%)	9.7	N/A	Clear Space?	N/A	
PROW/ADA: Not Found, R304.5.1, R304.2.2, R304.5.3		Road X Slope (%)	1.4	N/A	Clear Space to XWalk (in)	N/A	
	N/A	Any Obstructions?	N/A	N/A	Storm Grate/Utility Hazard?	N/A	
		Obstruction Type			Storm Grate/Utility Type		
			N/A			N/A	
				Yes	Surface Condition? (G/P)	Good	
	Total Cost:	\$	3200.00

Remove & Replace Curb Ramp With Two New Directional Ramps or Equivalent.
