Access Compliance Report

Public Rights-of-Way

(Curb Ramps)

Intersection ID: 14278	Main Street: ROMARE_BEARDEN_DR	Cross Street: FARMER_ST	Location: SW
ADA ID: 253F88C5EF97	Ramp Type: Perp	Initial Pass/Fail: Fail	Overall Compliance: No
Severity Score: 13.75			
Codes/Mitigation Info/Possible Solution		Field Measurements/Component Compliance

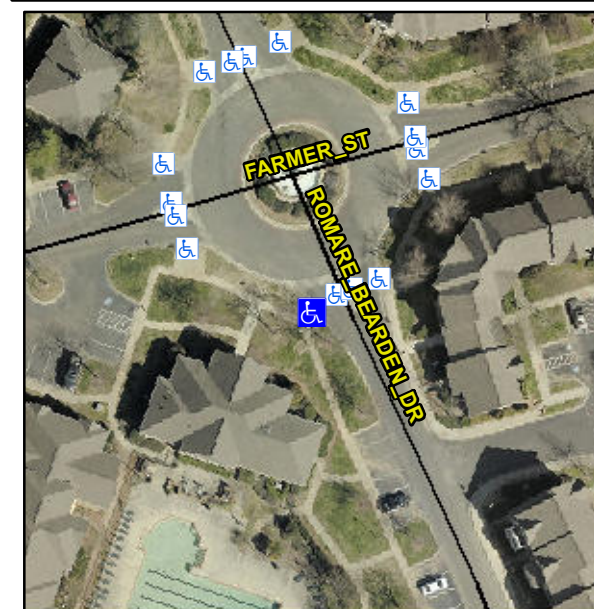
R304.2.2, R304.5.3

Compliance	Description	Data	Compliance	Description	Data
N/A	Ramp Length (in)	83.0	No	Ramp Slope (%)	10.4
Yes	Ramp Width (in)	49.0	No	Ramp XSlope (%)	3.0
N/A	Flare Type LT	N/A	N/A	Flare Type RT	N/A
N/A	Flare Slope LT (%)	N/A	N/A	Flare Slope RT (%)	N/A
N/A	Flare Traversable LT?	N/A	N/A	Flare Traversable RT?	N/A
N/A	Landing Length (in)	N/A	N/A	DWS Provided?	N/A
N/A	Landing Width (in)	N/A	N/A	DWS Contrast?	N/A
N/A	Landing Slope (%)	N/A	N/A	DWS Length (in)	N/A
N/A	Landing X Slope (%)	N/A	N/A	DWS Full Width?	N/A
N/A	Landing Curb? (Y/N)	N/A	N/A	DWS Offset (in)	N/A
N/A	Shared Landing?	N/A			
N/A	Gutter Ponding?	N/A	N/A	Gutter Slope (%)	N/A
N/A	Gutter Lip Ht (in)	N/A	N/A	Gutter X Slope (%)	N/A
N/A	Painted X Walk1?	No	N/A	Painted X Walk2?	N/A
	X Walk 1 Direction	To E		X Walk 2 Direction	N/A
N/A	X Walk 1 Width (in)	N/A	N/A	X Walk 2 Width (in)	N/A
	X Walk 1 Slope (%)	2.6		X Walk 2 Slope (%)	N/A
	X Walk 1 X Slope (%)	1.2		X Walk 2 X Slope (%)	N/A

Remove & Replace Entire Ramp.
