# Access Compliance Report

## Public Rights-of-Way

| Intersection ID: 15397 | Main Street: N_WENDOVER_RD | Cross Street: N_WENDOVER_RD_RA | Location: SE |
| ADA ID: 25FEDE914253 | Ramp Type: Perp | Initial Pass/Fail: Fail | Overall Compliance: No |

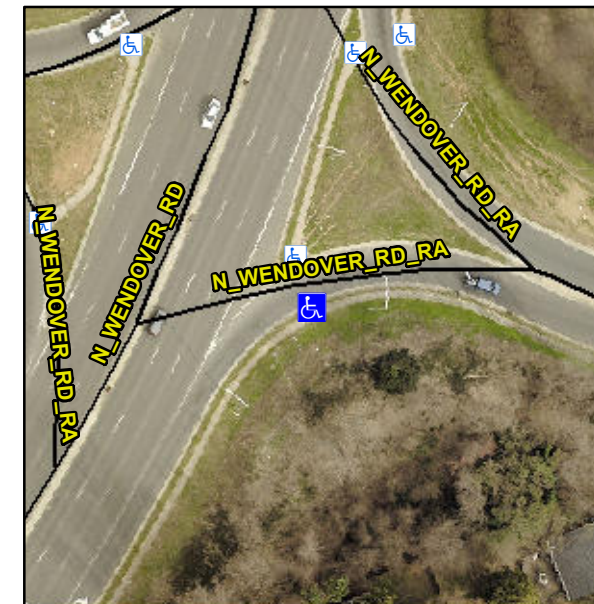
**Not Found, R304.5.1**

| Compliance | Description | Data | Compliance | Description | Data |
|---|---|---|---|---|---|
| No | Ramp Width (in) | 41.5 | Yes | Ramp XSlope (%) | 1.1 |

**Remove & Replace Entire Ramp.**
