# Access Compliance Report

## Public Rights-of-Way

### (Curb Ramps)

| Intersection ID: 2905 | Main Street: RIDGE_RD | Cross Street: SHELLEY_AV | Location: SE |

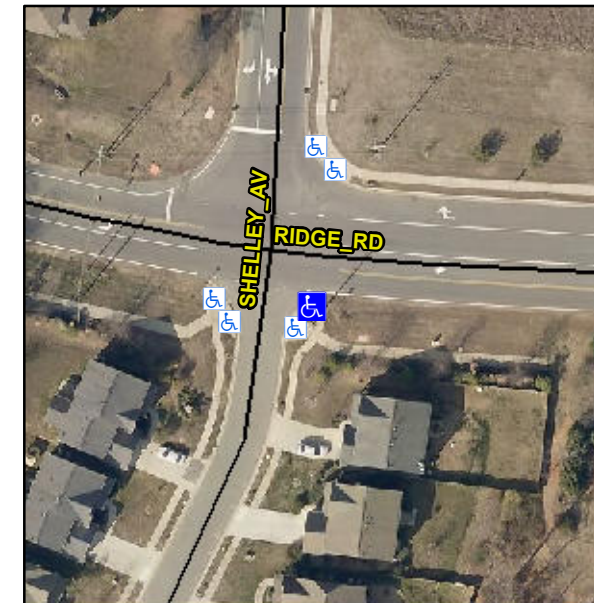
**NO LT FL CURB**

**Not Found, R304.5.1, R304.5.3**

**Remove & Replace Curb Ramp With Two New Directional Ramps or Equivalent.**
