Access Compliance Report

Public Rights-of-Way

(Curb Ramps)

Intersection ID: 10247	Main Street: BURTON_ST	Cross Street: WHISNANT_ST	Location: W
ADA ID: 2615878FC78A	Ramp Type: Combination1	Initial Pass/Fail: Fail	Overall Compliance: No
			Severity Score: 33.75

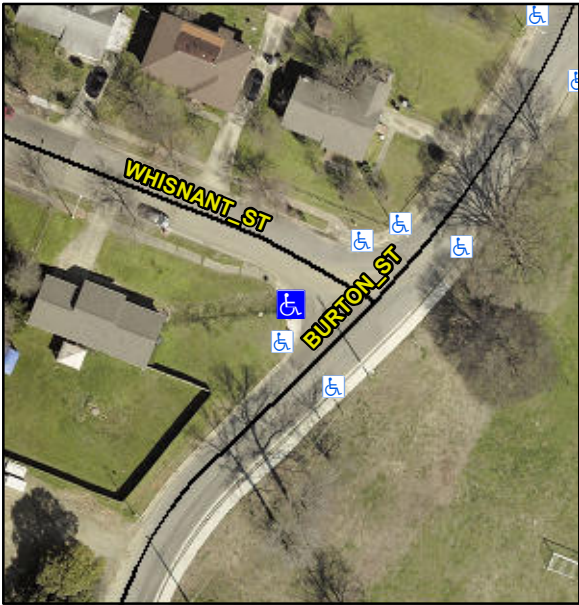
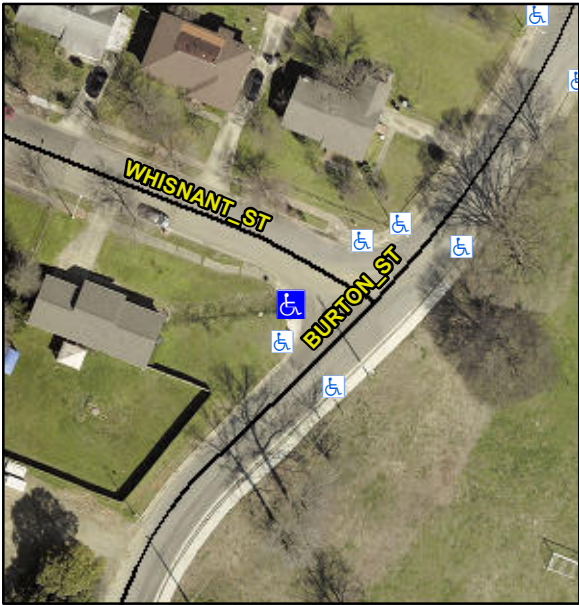
Possible Solutions:		Compliance	Description	Data	Compliance	Description	Data
	Remove & Replace Entire Ramp.		N/A	Ramp Length LT (in)	49.0	N/A	Ramp Length RT (in)	50.0
			Yes	Ramp Width LT (in)	55.0	Yes	Ramp Width RT (in)	56.0
			Yes	Ramp Slope LT (%)	0.9	Yes	Ramp Slope RT (%)	7.2
			No	Ramp XSlope LT (%)	3.0	No	Ramp XSlope RT (%)	5.5
			N/A	Ramp Length (in)	59.5	No	Ramp Slope (%)	10.8
			No	Ramp Width (in)	36.0	No	Ramp XSlope (%)	4.8
			N/A	Flare Type LT	N/A	N/A	Flare Type RT	N/A
			N/A	Flare Slope LT (%)	N/A	N/A	Flare Slope RT (%)	N/A
			N/A	Flare Traversable LT?	N/A	N/A	Flare Traversable RT?	N/A

Not Found, R304.5.1, R304.2.2, R304.5.3		N/A	Landing Curb? (Y/N)	N/A	N/A	DWS Offset (in)	N/A
			N/A	Shared Landing?	N/A			
			N/A	Gutter Ponding?	N/A	N/A	Gutter Slope (%)	N/A
			N/A	Gutter Lip Ht (in)	N/A	N/A	Gutter X Slope (%)	N/A
			N/A	Painted X Walk1?	No	N/A	Painted X Walk2?	N/A
				X Walk 1 Direction	To NE		X Walk 2 Direction	N/A
			X Walk 1 Width (in)	N/A		X Walk 2 Width (in)	N/A	
			X Walk 1 Slope (%)	4.1		X Walk 2 Slope (%)	N/A	
			X Walk 1 X Slope (%)	2.8		X Walk 2 X Slope (%)	N/A	
			Ramp inside XWalk1?	N/A	N/A	Ramp inside XWalk2?	N/A	
			Road Slope (%)	N/A		Clear Space?	N/A	
			Road X Slope (%)	N/A	N/A	Clear Space to XWalk (in)	N/A	
					N/A	Any Obstruction?	N/A	
						Obstruction Type	N/A	
								N/A
						N/A	Storm Grate/Utility Hazard?	N/A
							Storm Grate/Utility Type	N/A
								N/A
			Yes	Surface Condition? (G/P)	Good			
				Curb Slope (%)	45.4
