Access Compliance Report Public Rights-of-Way (Curb Ramps)

Intersection ID: 18132 Main Street: BRANDYWINE_RD Cross Street: HASSELL_PL Location: SE

ADA ID: 26AE0C18D87D Ramp Type: PerpDiag Initial Pass/Fail: Fail Overall Compliance: No Severity Score: 22.5

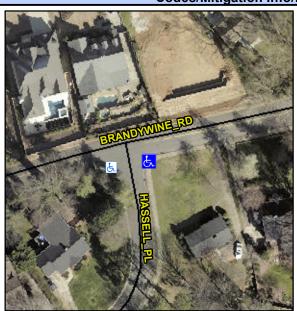
Not Found, R304.5.1, R304.2.2, R304.5.3

Field Measurements/Component Compliance						
	Compliance Description		Data	Comp	liance Description	Data
	N/A	Ramp Length (in)	28.0	No	Ramp Slope (%)	8.5
	No	Ramp Width (in)	44.0	No	Ramp XSlope (%)	4.8
	N/A	Flare Type LT	N/A	N/A	Flare Type RT	N/A
	N/A	Flare Slope LT (%)	N/A	N/A	Flare Slope RT (%)	N/A
	N/A	Flare Traversable LT?	N/A	N/A	Flare Traversable RT?	N/A
	N/A	Landing Length (in)	N/A	N/A	DWS Provided?	N/A
	N/A	Landing Width (in)	N/A	N/A	DWS Contrast?	N/A
	N/A	Landing Slope (%)	N/A	N/A	DWS Length (in)	N/A
	N/A	Landing X Slope (%)	N/A	N/A	DWS Full Width?	N/A
	N/A	Landing Curb? (Y/N)	N/A	N/A	DWS Offset (in)	N/A
	N/A	Shared Landing?	N/A			
	N/A	Gutter Ponding?	N/A	N/A	Gutter Slope (%)	N/A
	N/A	Gutter Lip Ht (in)	N/A	N/A	Gutter X Slope (%)	N/A
	N/A	Painted X Walk1?	No	N/A	Painted X Walk2?	No
		X Walk 1 Direction	To N		X Walk 2 Direction	To W
	N/A	X Walk 1 Width (in)	N/A	N/A	X Walk 2 Width (in)	N/A
		X Walk 1 Slope (%)	0.9		X Walk 2 Slope (%)	3.5

X Walk 1 X Slope (%)	1.8		X Walk 2 X Slope (%)	0.4
	N/A	Ramp inside XWalk1?	N/A	N/A	Ramp inside XWalk2?	N/A
		Road Slope (%)	0.2	N/A	Clear Space?	N/A
		Road X Slope (%)	2.9	N/A	Clear Space to XWalk (in)	N/A
	N/A	Any Obstructions?	N/A	N/A	Storm Grate/Utility Hazard?	N/A
		Obstruction Type			Storm Grate/Utility Type	
			N/A			N/A
				Yes	Surface Condition? (G/P)	Good
	A MO 1403	PART OF THE PART O		•

Remove & Replace Curb Ramp With Two New Directional Ramps or Equivalent.
