# Access Compliance Report

## Public Rights-of-Way

| Intersection ID: 25177 | Main Street: CARMEL_RD | Cross Street: MEADOWRIDGE_DR | Location: N |
| ADA ID: 26CB234B1776 | Ramp Type: ParaDiag | Initial Pass/Fail: Fail | Overall Compliance: No |

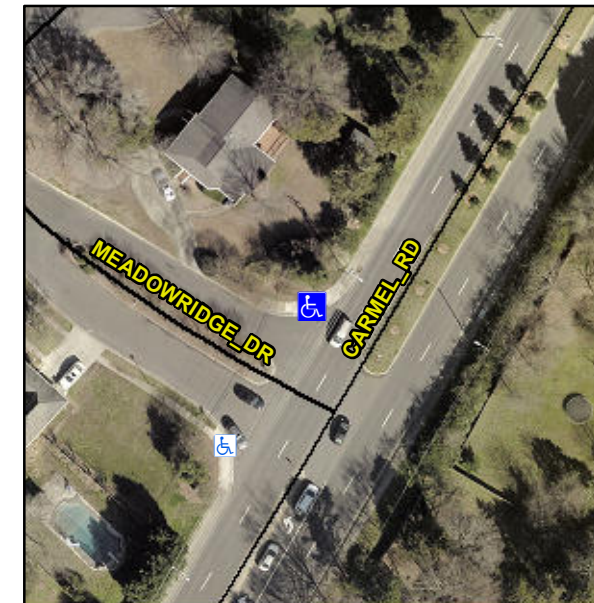
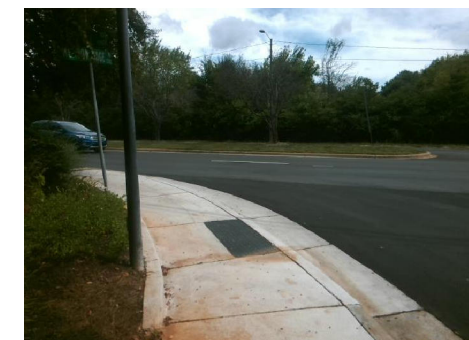
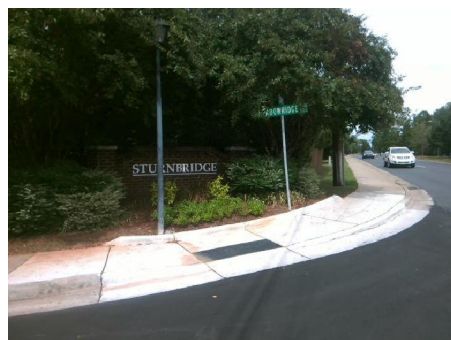
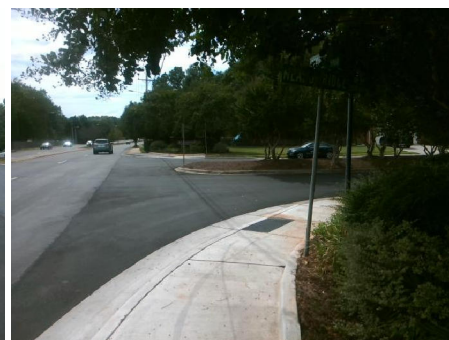
**LT RP < 5%**

**R304.3.2**

| Compliance | Description | Data | Compliance | Description | Data |
|---|---|---|---|---|---|
| Yes | Ramp Slope LT (%) | 2.9 | No | Ramp Slope RT (%) | 9.1 |

**Remove & Replace Curb Ramp With Two New Directional Ramps or Equivalent.**
