Access Compliance Report

Public Rights-of-Way

(Curb Ramps)

Intersection ID: 52127	Main Street: VALLEYDALE_RD	Cross Street: FRED_D_ALEXANDER_BV	Location: E
ADA ID: 26D249D4505D	Ramp Type: Combination1	Initial Pass/Fail: Fail	Overall Compliance: No
		Severity Score: 12.5

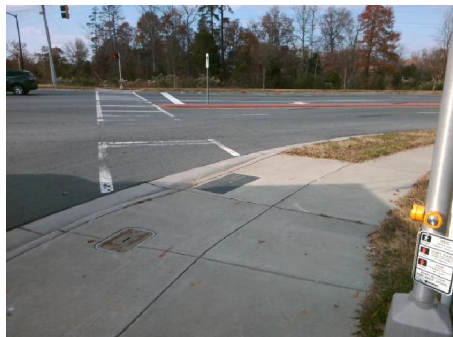
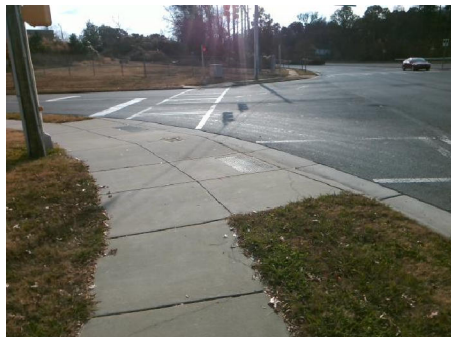
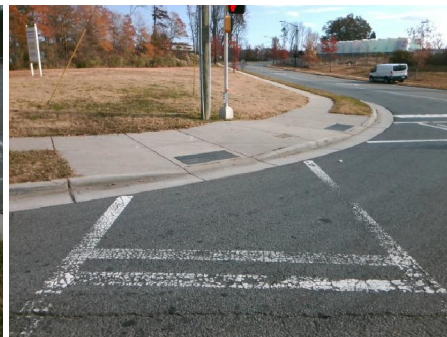
RP & LT RP < 5%

Not Found, R304.3.2

Compliance	Description	Data	Compliance	Description	Data
N/A	Ramp Length LT (in)	61.0	N/A	Ramp Length RT (in)	63.0
Yes	Ramp Width LT (in)	60.0	Yes	Ramp Width RT (in)	60.0
Yes	Ramp Slope LT (%)	3.2	No	Ramp Slope RT (%)	9.0
Yes	Ramp XSlope LT (%)	1.6	Yes	Ramp XSlope RT (%)	1.5
N/A	Ramp Length (in)	64.0	Yes	Ramp Slope (%)	2.1
Yes	Ramp Width (in)	57.0	Yes	Ramp XSlope (%)	0.3
N/A	Flare Type LT	N/A	N/A	Flare Type RT	N/A
N/A	Flare Slope LT (%)	N/A	N/A	Flare Slope RT (%)	N/A
N/A	Flare Traversable LT?	N/A	N/A	Flare Traversable RT?	N/A
N/A	Landing Length (in)	N/A	N/A	DWS Provided?	N/A
N/A	Landing Width (in)	N/A	N/A	DWS Contrast?	N/A
N/A	Landing Slope (%)	N/A	N/A	DWS Length (in)	N/A
N/A	Landing X Slope (%)	N/A	N/A	DWS Full Width?	N/A
N/A	Landing Curb? (Y/N)	N/A	N/A	DWS Offset (in)	N/A
N/A	Shared Landing?	N/A			
N/A	Gutter Ponding?	N/A	N/A	Gutter Slope (%)	N/A
N/A	Gutter Lip Ht (in)	N/A	N/A	Gutter X Slope (%)	N/A
N/A	Painted X Walk1?	Yes	N/A	Painted X Walk2?	N/A

Remove & Replace Entire Ramp.
