## Access Compliance Report Public Rights-of-Way (Curb Ramps)

Intersection ID: 46144 Main Street: EASTFIELD\_VILLAGE\_LN Cross Street: ROCKY\_FORD\_CLUB\_RD Location: N

ADA ID: 28456A96B2A3 Ramp Type: PerpDiag Initial Pass/Fail: Fail Overall Compliance: No Severity Score: 13.75

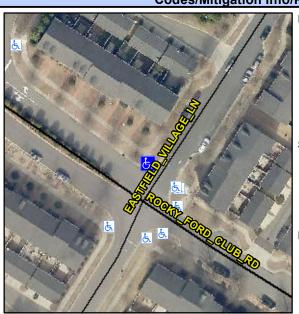
R304.2.2, R304.5.3

Compliance Description		Data	Comp	liance Description	Data
N/A	Ramp Length (in)	166.0	No	Ramp Slope (%)	9.6
Yes	Ramp Width (in)	48.0	No	Ramp XSlope (%)	3.9
N/A	Flare Type LT	N/A	N/A	Flare Type RT	N/A
N/A	Flare Slope LT (%)	N/A	N/A	Flare Slope RT (%)	N/A
N/A	Flare Traversable LT?	N/A	N/A	Flare Traversable RT?	N/A
N/A	Landing Length (in)	N/A	N/A	DWS Provided?	N/A
N/A	Landing Width (in)	N/A	N/A	DWS Contrast?	N/A
N/A	Landing Slope (%)	N/A	N/A	DWS Length (in)	N/A
N/A	Landing X Slope (%)	N/A	N/A	DWS Full Width?	N/A
N/A	Landing Curb? (Y/N)	N/A	N/A	DWS Offset (in)	N/A
N/A	Shared Landing?	N/A			
N/A	Gutter Ponding?	N/A	N/A	Gutter Slope (%)	N/A
N/A	Gutter Lip Ht (in)	N/A	N/A	Gutter X Slope (%)	N/A
N/A	Painted X Walk1?	No	N/A	Painted X Walk2?	No
	X Walk 1 Direction	To SW		X Walk 2 Direction	To SE
N/A	X Walk 1 Width (in)	N/A	N/A	X Walk 2 Width (in)	N/A
	X Walk 1 Slope (%)	1.4		X Walk 2 Slope (%)	3.7
	X Walk 1 X Slope (%)	2.8		X Walk 2 X Slope (%)	1.3

N/A	Ramp inside XWalk1?	N/A	N/A	Ramp inside XWalk2?	N/A
	Road Slope (%)	2.6	N/A	Clear Space?	N/A
	Road X Slope (%)	2.1	N/A	Clear Space to XWalk (in)	N/A
N/A	Any Obstructions?	N/A	N/A	Storm Grate/Utility Hazard?	N/A
	Obstruction Type		l	Storm Grate/Utility Type	
		N/A			N/A
			Yes	Surface Condition? (G/P)	Good

ROCK FORD CLUB None EASTFIELD VILLAGE LN StopSign Possible Solutions:

Remove & Replace Curb Ramp With
Two New Directional Ramps or
Equivalent.
