# Access Compliance Report

## Public Rights-of-Way

### (Curb Ramps)

| Intersection ID: 44262 | Main Street: AVERY_MEADOWS_DR | Cross Street: BELMONT_STABLES_DR | Location: NW |

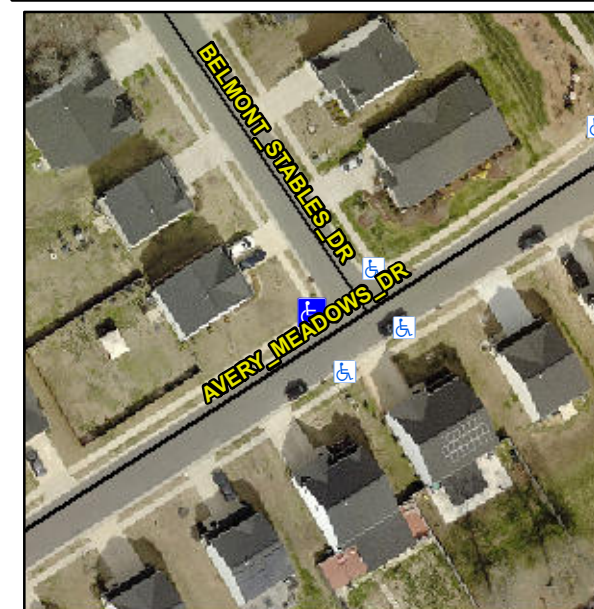
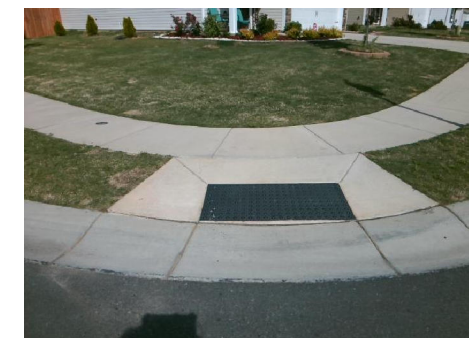
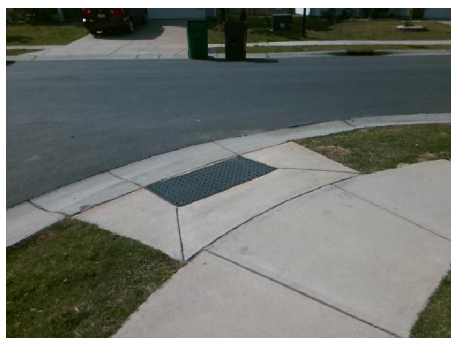
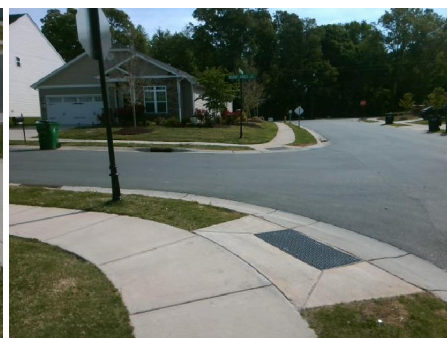
| ADA ID: 28AE0AF6CC85 | Ramp Type: PerpDiag | Initial Pass/Fail: Fail | Overall Compliance: No |

**Not Found, R304.2.2, R304.5.3**

| Compliance | Description | Data | Compliance | Description | Data |
|---|---|---|---|---|---|
| N/A | Ramp Length (in) | 48.0 | No | Ramp Slope (%) | 8.6 |
| Yes | Ramp Width (in) | 48.0 | No | Ramp XSlope (%) | 2.6 |

**Remove & Replace Curb Ramp With Two New Directional Ramps or Equivalent.**
