Access Compliance Report

Public Rights-of-Way

(Curb Ramps)

Intersection ID: 8706	Main Street: HALSEY_ST	Cross Street: ROZZELLES_FERRY_RD	Location: S
ADA ID: 2A334392FCFA	Ramp Type: Combination1	Initial Pass/Fail: Fail	Overall Compliance: No
Codes/Mitigation Info/Possible Solution		Field Measurements/Component Compliance	
Severity Score: 46.25

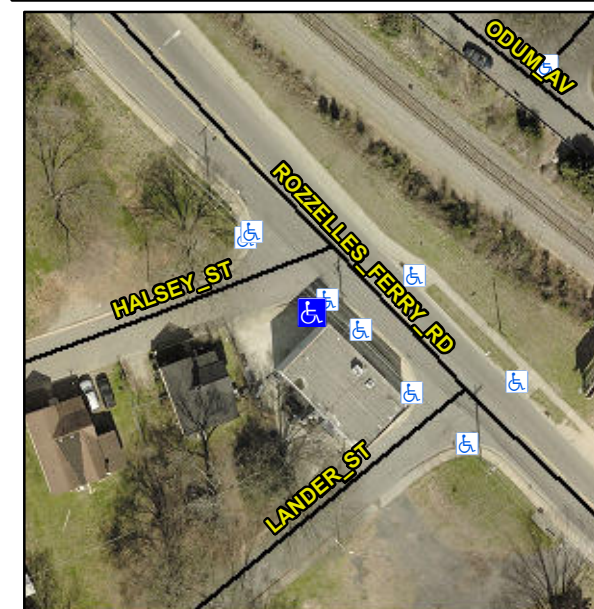
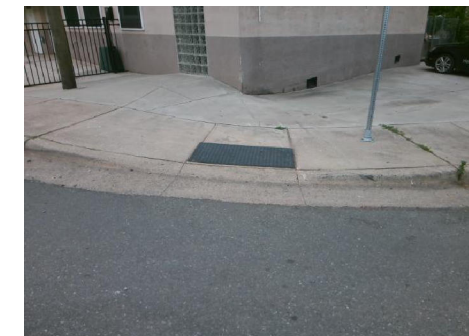
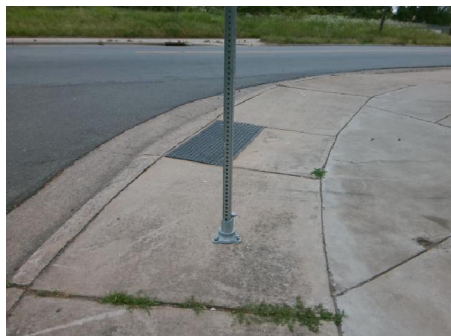
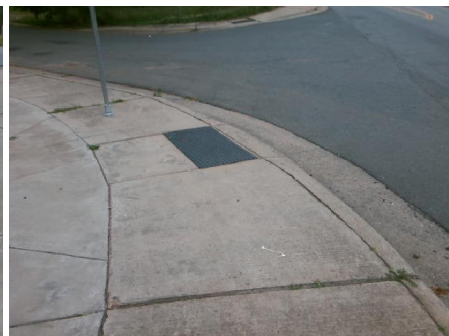
RP & LT RP < 5%

Not Found, R304.5.1, R304.5.3, R304.3.2

Compliance	Description	Data	Compliance	Description	Data
N/A	Ramp Length LT (in)	64.0	N/A	Ramp Length RT (in)	49.0
Yes	Ramp Width LT (in)	61.0	Yes	Ramp Width RT (in)	60.0
Yes	Ramp Slope LT (%)	0.9	No	Ramp Slope RT (%)	8.6
Yes	Ramp XSlope LT (%)	1.2	No	Ramp XSlope RT (%)	4.8
N/A	Ramp Length (in)	60.0	Yes	Ramp Slope (%)	0.9
No	Ramp Width (in)	42.0	No	Ramp XSlope (%)	8.1
N/A	Flare Type LT	N/A	N/A	Flare Type RT	N/A
N/A	Flare Slope LT (%)	N/A	N/A	Flare Slope RT (%)	N/A
N/A	Flare Traversable LT?	N/A	N/A	Flare Traversable RT?	N/A
N/A	Landing Length (in)	N/A	N/A	DWS Provided?	N/A
N/A	Landing Width (in)	N/A	N/A	DWS Contrast?	N/A
N/A	Landing Slope (%)	N/A	N/A	DWS Length (in)	N/A
N/A	Landing X Slope (%)	N/A	N/A	DWS Full Width?	N/A
N/A	Landing Curb? (Y/N)	N/A	N/A	DWS Offset (in)	N/A
N/A	Shared Landing?	N/A			
N/A	Gutter Ponding?	N/A	N/A	Gutter Slope (%)	N/A
N/A	Gutter Lip Ht (in)	N/A	N/A	Gutter X Slope (%)	N/A
N/A	Painted X Walk1?	No	N/A	Painted X Walk2?	N/A

Possible Solutions:

Remove & Replace Entire Ramp.
