Access Compliance Report

Public Rights-of-Way

| Intersection ID: 27388 | Main Street: BRIXHAM_HILL_AV | Cross Street: CONLAN_CR | Location: SE |
| ADA ID: 2A5E782B6D13 | Ramp Type: Perp | Initial Pass/Fail: Fail | Overall Compliance: No |

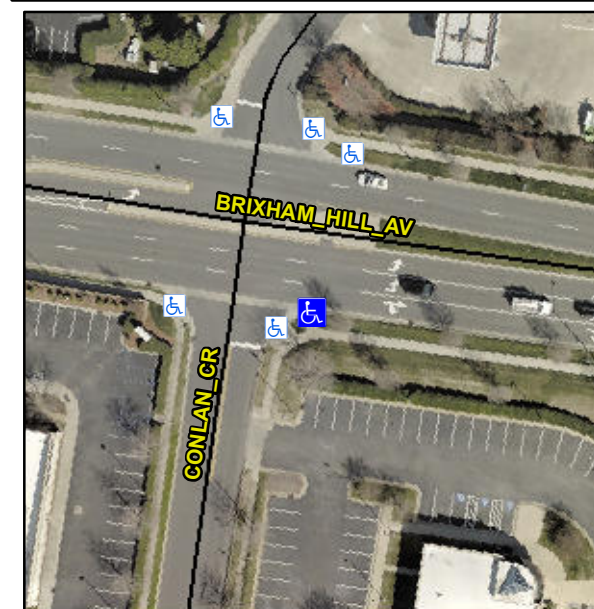
| Codes/Mitigation Info/Possible Solution | | | Severity Score: 25 |

R304.2.2, R304.5.3

| Compliance | Description | Data | Compliance | Description | Data |
|---|---|---|---|---|---|
| N/A | Ramp Length (in) | 96.0 | No | Ramp Slope (%) | 8.7 |
| Yes | Ramp Width (in) | 58.0 | No | Ramp XSlope (%) | 5.3 |

Remove & Replace Entire Ramp.
