Access Compliance Report Public Rights-of-Way (Curb Ramps)

Intersection ID: 47852Main Street: CACTUS_VALLEY_RDCross Street: STONE_PORCH_RDLocation:NEADA ID: 2A620506DA5ERamp Type: PerpInitial Pass/Fail: FailOverall Compliance: NoSeverity Score: 8.75

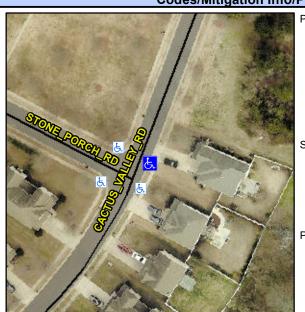
1 OSSIDIE SOIGLIOII	
Possible Solutions:	c
Remove & Replace Entire Ramp.	
•	N
	N/
	N
	N
	N
Surveyor Notes:	N
N/A	N
	N
	N
	N
PROW/ADA:	N
Not Found, R304.5.1	N
•	N
	N
	N

Field Measurements/Component Compliance							
Comp	liance Description	Data	Comp	liance	Description	Data	
N/A	Ramp Length (in)	47.5	Yes	Ramp	Slope (%)	7.0	
No	Ramp Width (in)	47.0	Yes	Ramp	XSlope (%)	2.0	
N/A	Flare Type LT	N/A	N/A	Flare	Type RT	N/A	
N/A	Flare Slope LT (%)	N/A	N/A	Flare	Slope RT (%)	N/A	
N/A	Flare Traversable LT?	N/A	N/A	Flare	Traversable RT?	N/A	
N/A	Landing Length (in)	N/A	N/A	DWS	Provided?	N/A	
N/A	Landing Width (in)	N/A	N/A	DWS	Contrast?	N/A	
N/A	Landing Slope (%)	N/A	N/A	DWS	Length (in)	N/A	
N/A	Landing X Slope (%)	N/A	N/A	DWS	Full Width?	N/A	
N/A	Landing Curb? (Y/N)	N/A	N/A	DWS	Offset (in)	N/A	
N/A	Shared Landing?	N/A					
N/A	Gutter Ponding?	N/A	N/A	Gutte	r Slope (%)	N/A	
N/A	Gutter Lip Ht (in)	N/A	N/A	Gutte	r X Slope (%)	N/A	
N/A	Painted X Walk1?	No	N/A	Paint	ed X Walk2?	N/A	
	X Walk 1 Direction	To NW		X Wa	lk 2 Direction	N/A	
N/A	X Walk 1 Width (in)	N/A	N/A	X Wa	lk 2 Width (in)	N/A

X Walk 1 Slope (%)	2.2		X Wa	lk 2 Slope (%)	N/A	
	X Walk 1 X Slope (%)	1.9		X Wa	lk 2 X Slope (%)	N/A	
N/A	Ramp inside XWalk1?	N/A	N/A	Ramp	inside XWalk2?	N/A	
	Road Slope (%)	N/A	N/A	Clear	Space?	N/A	
	Road X Slope (%)	N/A	N/A	Clear	Space to XWalk (in)	N/A	
N/A	Any Obstructions?	N/A	N/A		Grate/Utility Hazard?	N/A	
	Obstruction Type				n Grate/Utility Type		
	, ,	N/A			, ,,	N/A	
			Yes	Surfa	ce Condition? (G/P)	Good	
					(-·)
